No.76 IACS Guidelines for Surveys, Assessment and Repair of Hull Structure – Bulk Carriers

(1994)
(Rev.1
July 2001)
(Rev.2
June 2004)
(Corr.1
Sept 2007)

Guidelines for Surveys, Assessment and Repair of Hull
Structure

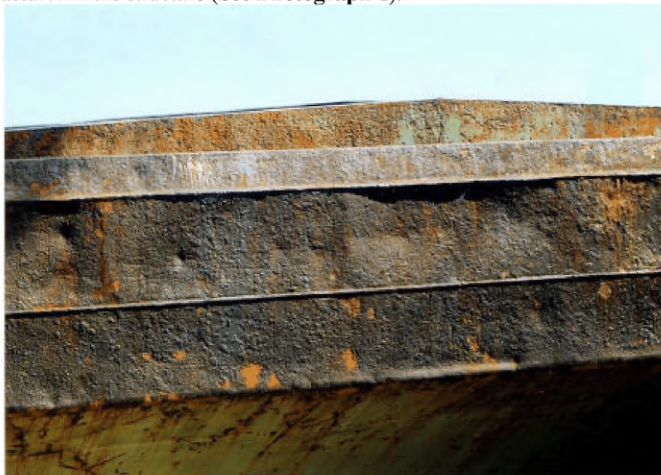
Photograph 1 Heavy corrosion of hatch coaming and topside tank plating vertical strake

- 3.1.1** The level of wastage of under-deck stiffeners/structure in cross deck may have to be established by means of thickness measurements. The combined effect of the marine environment and the high humidity atmosphere within cargo holds will give rise to a high corrosion rate.
- 3.1.2** Severe corrosion of the hatch coaming plating inside cargo hold and topside tank plating vertical strake may occur due to difficult access for the maintenance of the protective coating. This may lead to fractures in the structure (See **Photograph 1**).

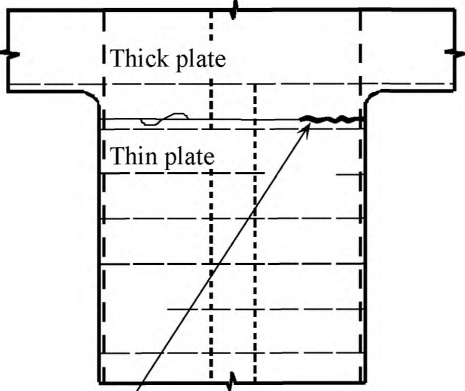
BULK CARRIERS		Guidelines for Surveys, Assessment and Repair of Hull Structure	
Part 1	Cargo hold region	Example No.	
Area 1	Deck structure	2-a	
Detail of damage		Fractures of welded seam between thick plate and thin plate at cross deck	
<p>Sketch of damage</p>

<p>Insert plate of suitable intermediate thickness</p>	
<p>Notes on possible cause of damage</p> <ol style="list-style-type: none"> 1. Stress concentration created by abrupt change in deck plating thickness. 2. In-plane bending in cross deck strip due to torsional (longitudinal) movements of ship sides. 3. Welded seam not clear of tangent point of hatch corner. 		<p>Notes on repairs</p> <ol style="list-style-type: none"> 1. Insert plate of intermediate thickness is recommended. 2. Smooth transition between plates (beveling) should be considered.

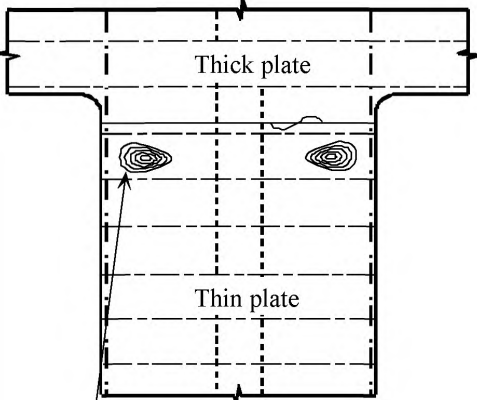
BULK CARRIERS		Guidelines for Surveys, Assessment and Repair of Hull Structure	
Part 1	Cargo hold region	Example No.	
Area 1	Deck structure	2-b	
Detail of damage		Plate buckling in thin plate near thick plate at cross deck	
Sketch of damage		Sketch of repair

<p>Buckling of cross deck plating (Buckling of hatch end structure should be examined. Refer to Example 7-a.)</p>

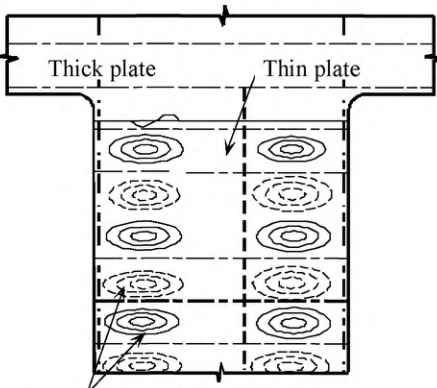
BULK CARRIERS		Guidelines for Surveys, Assessment and Repair of Hull Structure	
Part 1	Cargo hold region	Example No.	
Area 1	Deck structure	2-c	
Detail of damage		Overall buckling of cross deck plating	
<p>Sketch of damage</p>

<p>Buckling of cross deck plating (Buckling of hatch end structure should be examined. Refer to Example 7-a.)</p>		<p>Sketch of repair</p> <p>Repair A</p>

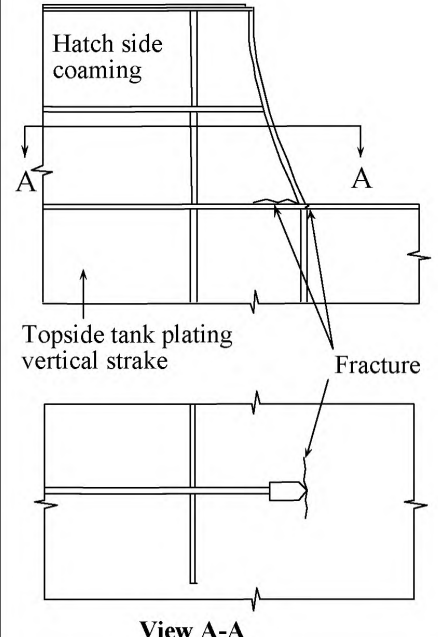
BULK CARRIERS		Guidelines for Surveys, Assessment and Repair of Hull Structure	
Part 1	Cargo hold region	Example No.	
Area 1	Deck structure	3-a	
Detail of damage		Fractures in the web or in the deck at the toes of the longitudinal hatch coaming termination bracket	
<p>Sketch of damage</p>

<p>View X-X</p>	
<p>Notes on possible cause of damage</p> <ol style="list-style-type: none"> 1. This damage is caused by stress concentrations attributed to the design of the bracket. 		<p>Notes on repairs</p> <ol style="list-style-type: none"> 1. The design of the bracket can be altered as shown above, however, it is to be ensured that an additional under deck stiffener is provided at the toe of the termination bracket, where the toe is clear of the normal stiffening member. 2. Full penetration weld for a distance of $0.15 H_C$ from toe of side coaming termination bracket and for connection of athwartship gusset bracket to deck. 3. The fracture in deck plating to be veed-out and rewelded or deck plating cropped and part renewed as appropriate, using low hydrogen electrodes for welding.

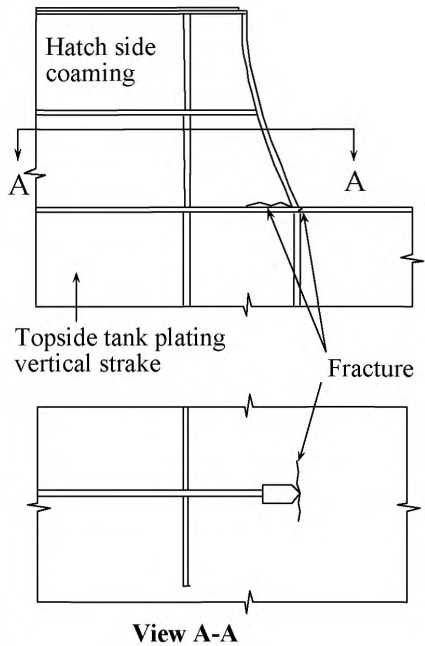
BULK CARRIERS		Guidelines for Surveys, Assessment and Repair of Hull Structure	
Part 1	Cargo hold region	Example No.	
Area 1	Deck structure	3-b	
Detail of damage		Fractures in the web or in the deck at the toes of the longitudinal hatch coaming termination bracket	
<p>Sketch of damage</p>

<p>Hatch side coaming</p> <p>Topside tank plating vertical strake</p> <p>Fracture</p> <p>View A-A</p>		<p>Sketch of repair</p>

<p>500R</p> <p>150 30</p> <p>70</p> <p>15</p> <p>4 4</p> <p>50 7</p> <p>25R</p> <p>60</p> <p>135</p>	
<p>Notes on possible cause of damage</p> <ol style="list-style-type: none"> 1. This damage is caused by stress concentrations attributed to the design of the bracket. 		<p>Notes on repairs</p> <ol style="list-style-type: none"> 1. The design of the bracket can be altered as shown above, however, it is to be ensured that an additional under deck stiffener is provided at the toe of the termination bracket, where the toe is clear of the normal stiffening member. 2. The fracture in deck plating to be veed-out and rewelded or deck plating cropped and part renewed as appropriate, using low hydrogen electrodes for welding.

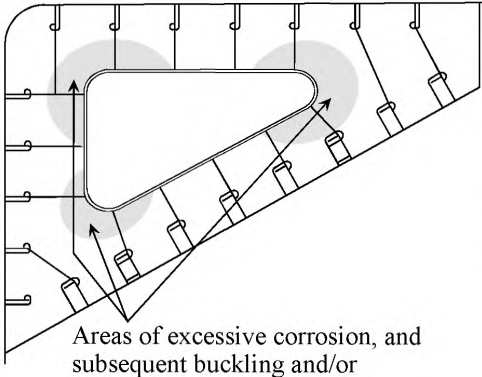
<p>Areas of excessive corrosion, and subsequent buckling and/or</p>

<p>Additional stiffeners</p>	
Notes on possible cause of damage		Notes on repairs	
<ol style="list-style-type: none"> 1. Insufficient buckling strength. 2. Corrosion due to stress concentration at corners. 		<ol style="list-style-type: none"> 1. Buckled plating is to be cropped and parts renewed, if necessary. 2. Additional stiffeners as shown above and/or renewal with plating of increased thickness should be considered.

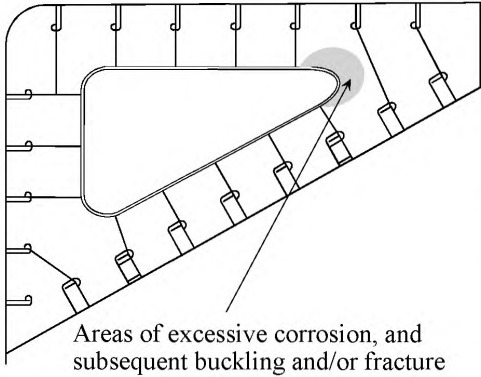
<p>Areas of excessive corrosion, and subsequent buckling and/or fracture</p>

<p>Enlarged radius of the opening</p>	
Notes on possible cause of damage		Notes on repairs	
<ol style="list-style-type: none"> 1. Corrosion caused by stress concentration at the corner due to insufficient radius for the opening. 		<ol style="list-style-type: none"> 1. Corroded/buckled plating is to be cropped and parts renewed with plating of increased thickness and additional stiffeners are preferable to minimize deflection. 2. An attempt should be made to improve the design of the radius if felt necessary.

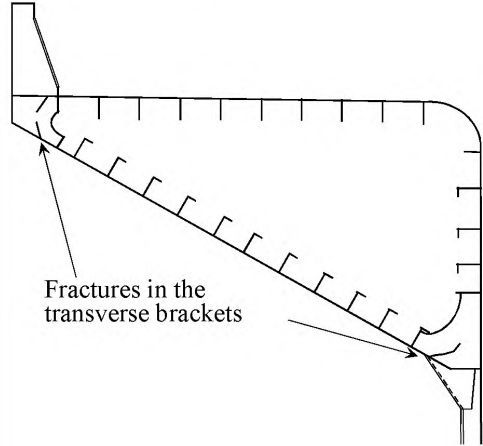
<p>Fractures in the transverse brackets</p>

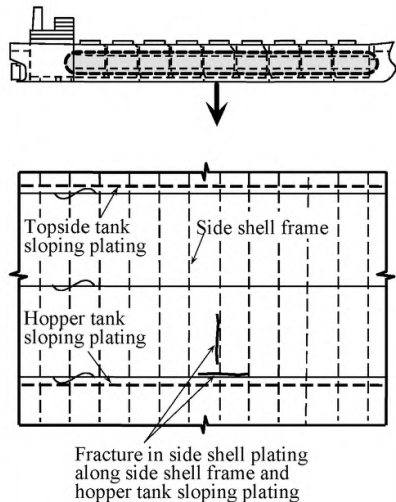
<p>Topside tank sloping plating</p> <p>Side shell frame</p> <p>Hopper tank sloping plating</p> <p>Fracture in side shell plating along side shell frame and hopper tank sloping plating</p>

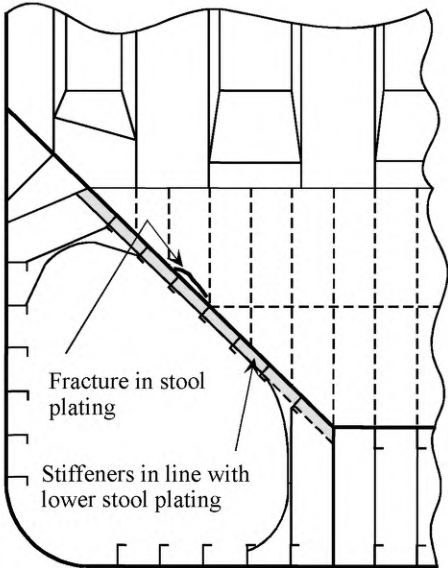
<p>Fracture in stool plating</p> <p>Stiffeners in line with lower stool plating</p>

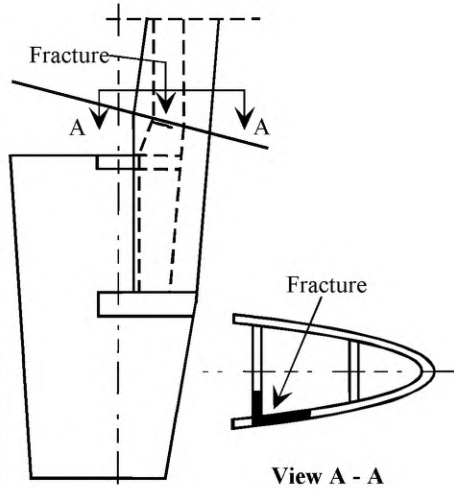
<p>The sketch shows a cross-section of the rudder horn structure. A diagonal line labeled 'Fracture' indicates the location of the damage. Below it, 'View A - A' shows a detailed view of the bottom shell plating with a similar fracture line.</p>
