No.76 IACS Guidelines for Surveys, Assessment and Repair of Hull Structure – Bulk Carriers

(1994)
(Rev.1
July 2001)
(Rev.2
June 2004)
(Corr.1
Sept 2007)

Guidelines for Surveys, Assessment and Repair of Hull
Structure

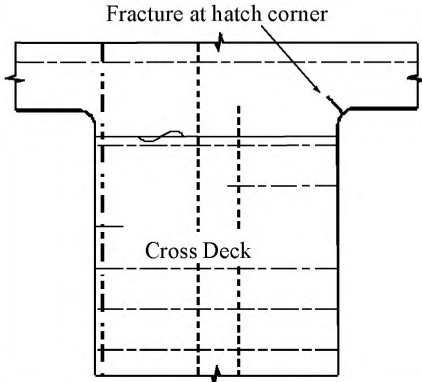
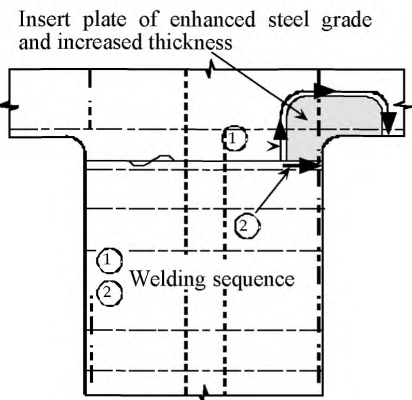
BULK CARRIERS		Guidelines for Surveys, Assessment and Repair of Hull Structure	
Part 1	Cargo hold region	Example No.	
Area 1	Deck structure	1	
Detail of damage		Fractures at main cargo hatch corner	
Sketch of damage		Sketch of repair

<p>Fracture at hatch corner</p> <p>Cross Deck</p>

<p>Insert plate of enhanced steel grade and increased thickness</p> <p>① ② Welding sequence</p>	
Notes on possible cause of damage		Notes on repairs	
<ol style="list-style-type: none"> 1. Stress concentration at hatch corners, i.e. radius of corner. 2. Welded attachment of shedder plate close to edge of hatch corner. 3. Wire rope groove. 		<ol style="list-style-type: none"> 1. The corner plating in way of the fracture is to be cropped and renewed. If stress concentration is primary cause, insert plate should be increased thickness, enhanced steel grade and/or improved geometry. Insert plate should be continued beyond the longitudinal and transverse extent of the hatch corner radius ellipse or parabola, and the butt welds to the adjacent deck plating should be located well clear of the butts in the hatch coaming. It is recommended that the edges of the insert plate and the butt welds connecting the insert plates to the surrounding deck plating be made smooth by grinding. In this respect caution should be taken to ensure that the micro grooves of the grinding are parallel to the plate edge. 2. If the cause of fracture is welded attachment of shedder plate, the deck connection should be left unwelded. 3. If the cause of the fracture is wire rope groove, replacement to the original design can be accepted.

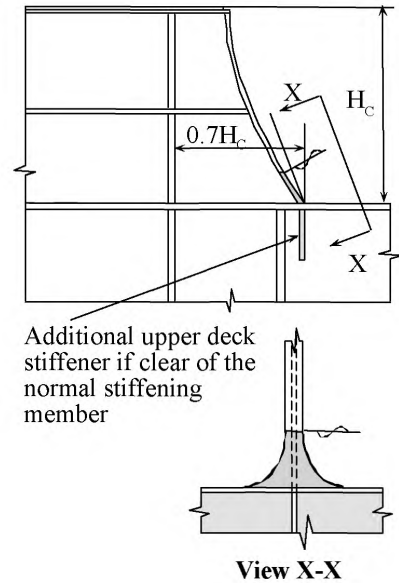
<p>View X-X</p>	
<p>Notes on possible cause of damage</p> <ol style="list-style-type: none"> 1. This damage is caused by stress concentrations attributed to the design of the bracket. 		<p>Notes on repairs</p> <ol style="list-style-type: none"> 1. The design of the bracket can be altered as shown above, however, it is to be ensured that an additional under deck stiffener is provided at the toe of the termination bracket, where the toe is clear of the normal stiffening member. 2. Full penetration weld for a distance of $0.15 H_C$ from toe of side coaming termination bracket and for connection of athwartship gusset bracket to deck. 3. The fracture in deck plating to be veed-out and rewelded or deck plating cropped and part renewed as appropriate, using low hydrogen electrodes for welding.

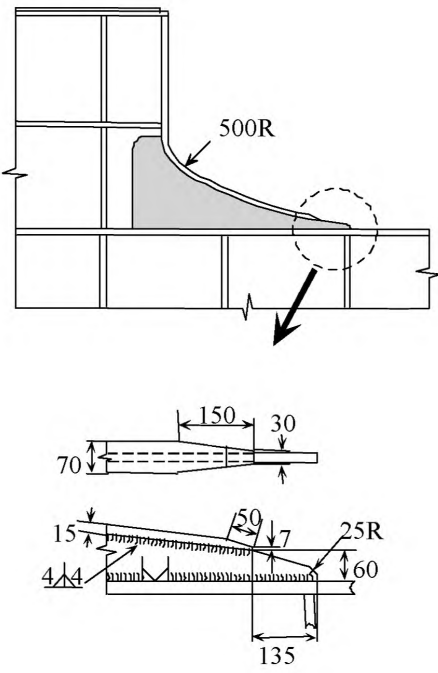
BULK CARRIERS		Guidelines for Surveys, Assessment and Repair of Hull Structure	
Part 1	Cargo hold region	Example No.	
Area 1	Deck structure	3-b	
Detail of damage		Fractures in the web or in the deck at the toes of the longitudinal hatch coaming termination bracket	
<p>Sketch of damage</p>

<p>Hatch side coaming</p> <p>Topside tank plating vertical strake</p> <p>Fracture</p> <p>View A-A</p>		<p>Sketch of repair</p>

<p>500R</p> <p>150 30</p> <p>70</p> <p>15</p> <p>4 4</p> <p>50 7</p> <p>25R</p> <p>60</p> <p>135</p>	
<p>Notes on possible cause of damage</p> <ol style="list-style-type: none"> 1. This damage is caused by stress concentrations attributed to the design of the bracket. 		<p>Notes on repairs</p> <ol style="list-style-type: none"> 1. The design of the bracket can be altered as shown above, however, it is to be ensured that an additional under deck stiffener is provided at the toe of the termination bracket, where the toe is clear of the normal stiffening member. 2. The fracture in deck plating to be veed-out and rewelded or deck plating cropped and part renewed as appropriate, using low hydrogen electrodes for welding.

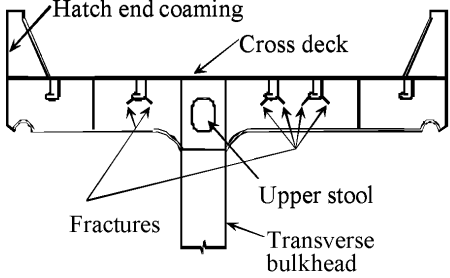
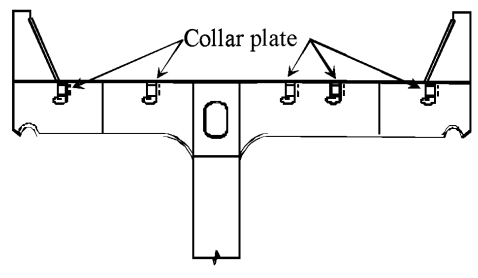
BULK CARRIERS		Guidelines for Surveys, Assessment and Repair of Hull Structure	
Part 1	Cargo hold region	Example No.	
Area 1	Deck structure	6	
Detail of damage		Fractures around cut-outs in cross deck girder	
<p>Sketch of damage</p>

<p>The sketch shows a cross-section of a deck structure. A horizontal cross deck girder is supported by an upper stool, which is attached to a transverse bulkhead. There are cut-outs in the cross deck girder. Arrows point to fractures in the web plate of the cross deck girder around these cut-outs. Hatch end coaming is also shown.</p>		<p>Sketch of repair</p>

<p>The sketch shows the same cross-section as the damage sketch, but with repair work. Collar plates are shown being welded around the cut-outs in the cross deck girder to reinforce the structure.</p>	
<p>Notes on possible cause of damage</p> <ol style="list-style-type: none"> 1. Stress concentration at the cut-outs in cross deck girder. 		<p>Notes on repairs</p> <ol style="list-style-type: none"> 1. Fractured web plate of cross deck girder to be cropped and part renewed. 2. Collar plates to be provided.

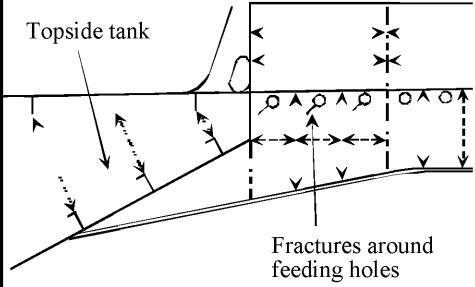
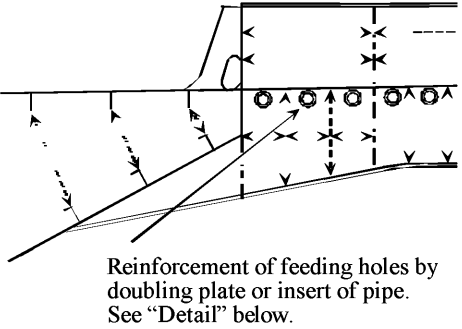
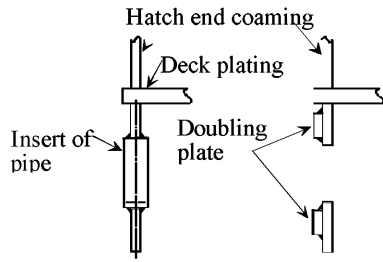
BULK CARRIERS		Guidelines for Surveys, Assessment and Repair of Hull Structure	
Part 1	Cargo hold region	Example No.	
Area 1	Deck structure	9	
Detail of damage		Fractures in hatch end beam around feeding holes	
<p>Sketch of damage</p>

<p>Notes on possible cause of damage</p> <ol style="list-style-type: none"> 1. Inadequate reinforcement around feeding hole. 2. Corrosion. 		<p>Notes on repairs</p> <ol style="list-style-type: none"> 1. Fractured part to be veed-out or cropped and renewed. 2. If the fractured part is free from corrosion, reinforcement should be considered.

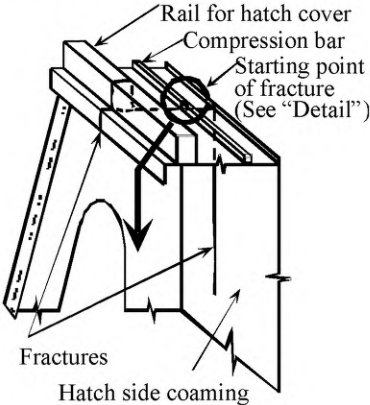
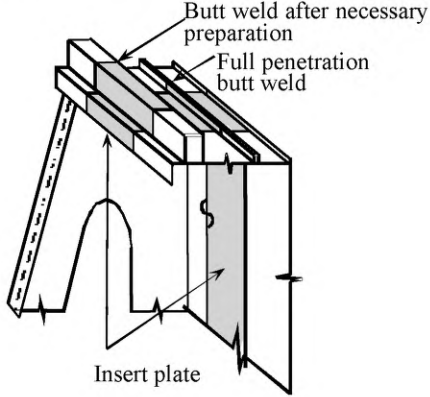
BULK CARRIERS		Guidelines for Surveys, Assessment and Repair of Hull Structure	
Part 1	Cargo hold region	Example No.	
Area 1	Deck structure	11	
Detail of damage		Fractures in hatch coaming top plate initiated from butt weld of compression bar	
<p>Sketch of damage</p>

<p>Notes on possible cause of damage</p> <ol style="list-style-type: none"> 1. Heavy weather 2. Insufficient preparation of weld of compression bar and/or rail (Although the compression bar and rail are not longitudinal strength members, they subject same longitudinal stress as longitudinal members) 3. Crack may initiate from insufficient penetration of weld of rail for hatch cover. 		<p>Notes on repairs</p> <ol style="list-style-type: none"> 1. Loading condition of the ship and proper welding procedure should be carefully considered. 2. Fractured structure is to be cropped and renewed if considered necessary. (Small fracture may be vee-d-out and rewelded.) 3. Full penetration welding should be applied to the butt weld of compression bar and rail.

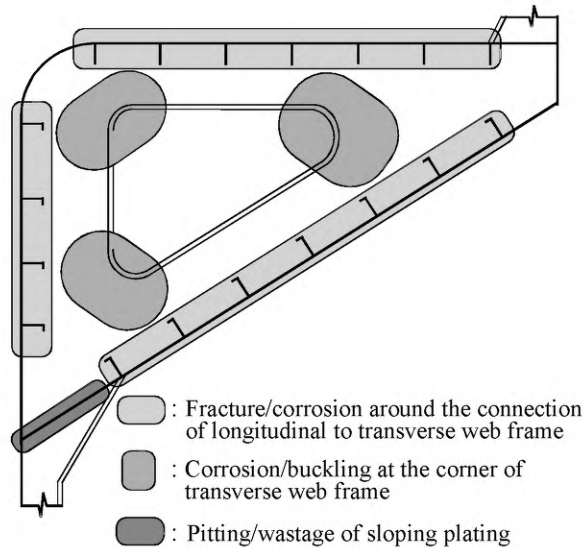
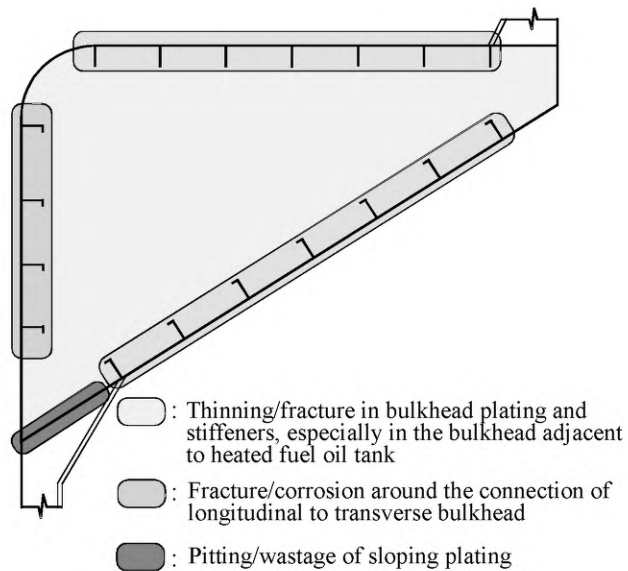
Figure 1 Topside tank - Potential problem areas

2.1.2 Rate and extent of corrosion depends on the environmental conditions, and protective measures employed, such as coatings and sacrificial anodes. The following structures are generally susceptible to corrosion (See **Figure 1**).

- (a) Structure in corrosive environment
 - Deck plating and deck longitudinal
 - Transverse bulkhead adjacent to heated fuel oil tank
 - Lowest part of sloping plating
- (b) Structure subject to high stress
 - Face plates and web plates of transverse at corners
 - Connection of side longitudinal to transverse
- (c) Areas susceptible to coating breakdown
 - Back side of face plate of longitudinal
 - Welded joint
 - Edge of access opening
- (d) Areas subjected to poor drainage
 - Web of side and sloping longitudinals

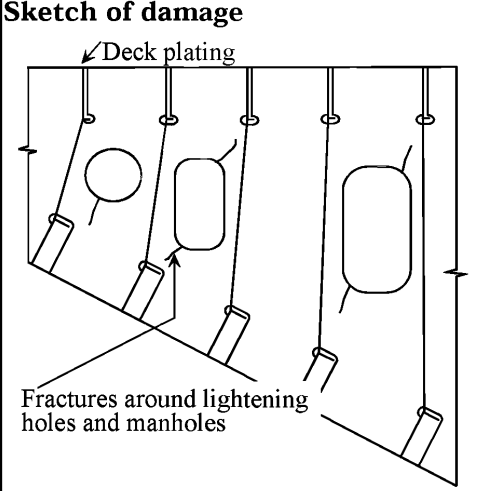
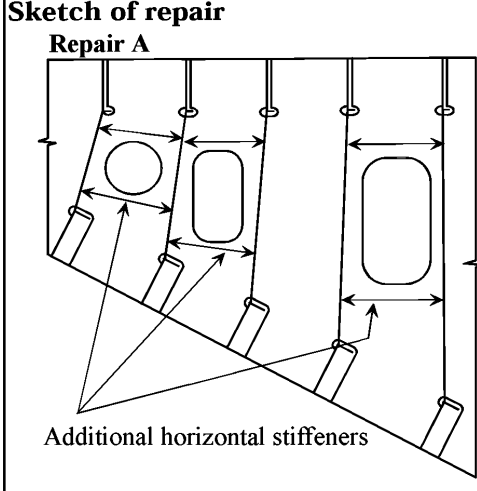
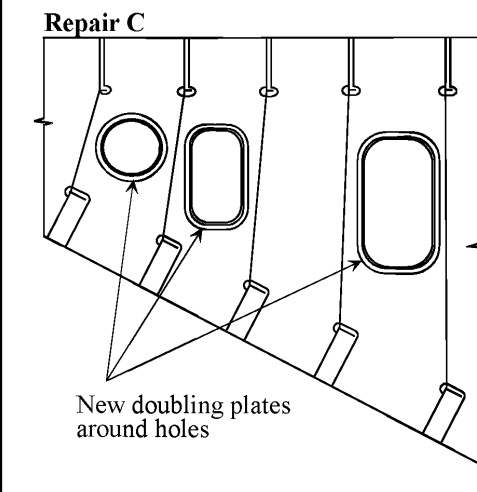
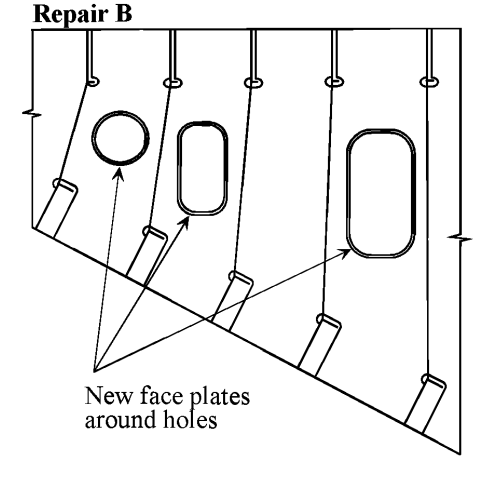
BULK CARRIERS		Guidelines for Surveys, Assessment and Repair of Hull Structure	
Part 1	Cargo hold region	Example No.	
Area 2	Topside tank structure	1	
Detail of damage		Fractures around unstiffened lightening holes and manholes in wash bulkhead	
Sketch of damage		Sketch of repair

Notes on possible cause of damage		Notes on repairs	
<ol style="list-style-type: none"> 1. General levels of corrosion and presence of stress concentration. 		<ol style="list-style-type: none"> 1. Corroded/fractured plate should be cropped and renewed with plating of enhanced thickness. 2. Reinforcement should be considered.

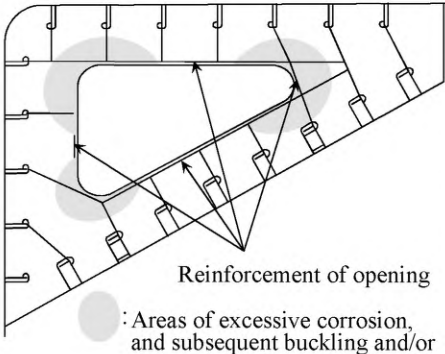
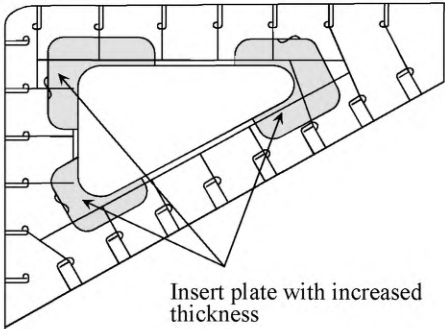
BULK CARRIERS		Guidelines for Surveys, Assessment and Repair of Hull Structure	
Part 1	Cargo hold region	Example No.	
Area 2	Topside tank structure	2-c	
Detail of damage	Thinning and subsequent buckling of web plating in the vicinity of the radii of the opening		
Sketch of damage		Sketch of repair

<p>Reinforcement of opening</p> <p>: Areas of excessive corrosion, and subsequent buckling and/or</p>

<p>Insert plate with increased thickness</p>	
Notes on possible cause of damage		Notes on repairs	
<p>1. Additional stresses at the free edge of transverse web. (In Example 2-a - 2-c face plate is provided for the reinforcement of the opening.)</p>		<p>1. Corroded/buckled plating is to be cropped and part renewed with plating of increased thickness.</p>

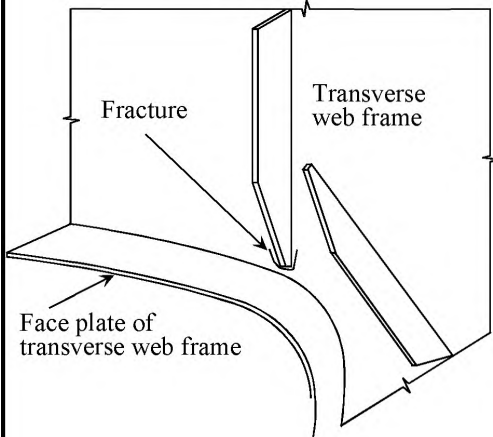
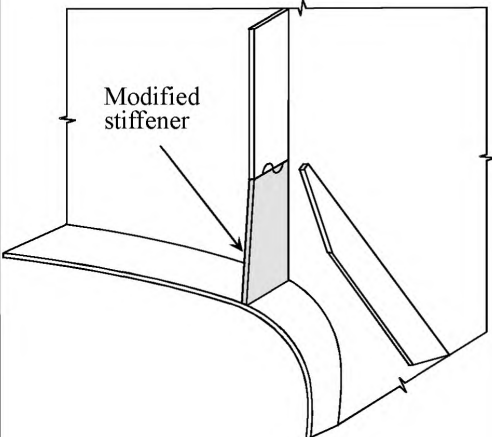
BULK CARRIERS		Guidelines for Surveys, Assessment and Repair of Hull Structure	
Part 1	Cargo hold region	Example No.	
Area 2	Topside tank structure	3	
Detail of damage		Fractures in transverse web at sniped end of stiffener	
Sketch of damage		Sketch of repair

Notes on possible cause of damage		Notes on repairs	
<ol style="list-style-type: none"> 1. Stress concentration. 		<ol style="list-style-type: none"> 1. Fracture can be veed-out and welded provided the plating is not generally corroded. If necessary, fractured plating should be cropped and renewed. 2. Excessive stress concentration at the end of stiffener should be avoided.

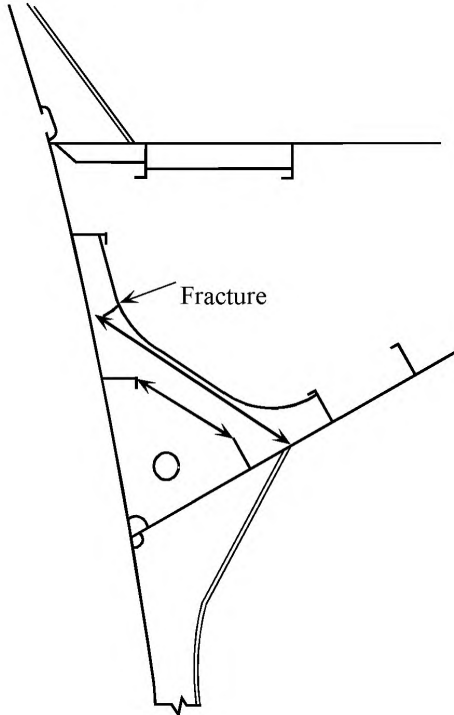
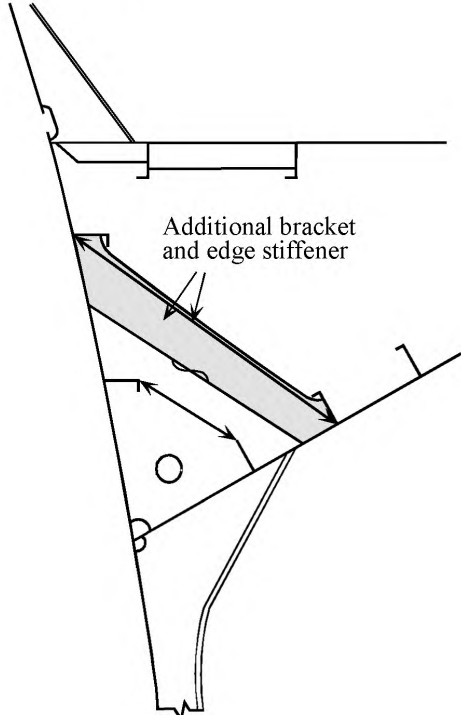
BULK CARRIERS		Guidelines for Surveys, Assessment and Repair of Hull Structure	
Part 1	Cargo hold region	Example No.	
Area 2	Topside tank structure	7-b	
Detail of damage		Fractures in transverse bracket	
Sketch of damage		Sketch of repair

Notes on possible cause of damage		Notes on repairs	
<ol style="list-style-type: none"> 1. Insufficient strength. 2. Corrosion. 		<ol style="list-style-type: none"> 1. Fractured part to be cropped and renewed. 2. If the fractured part is free from corrosion, increased size and thickness should be considered. Partial renewal of the bracket may be accepted depending on the nature of the fracture.

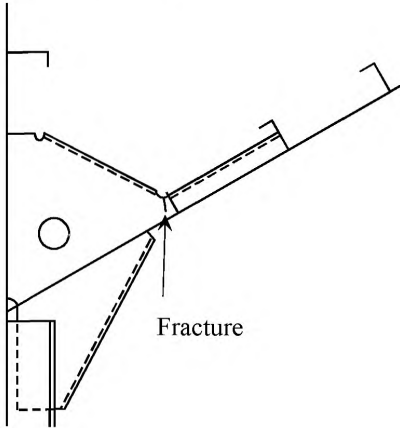
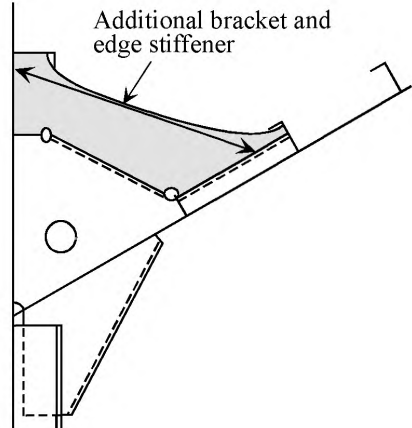
BULK CARRIERS		Guidelines for Surveys, Assessment and Repair of Hull Structure	
Part 1	Cargo hold region	Example No.	
Area 2	Topside tank structure	7-c	
Detail of damage		Fractures at toes of transverse bracket	
Sketch of damage		Sketch of repair

Notes on possible cause of damage		Notes on repairs	
<ol style="list-style-type: none"> 1. Stress concentration due to the shape of the bracket. 		<ol style="list-style-type: none"> 1. Cracked weld to be veed-out and rewelded.

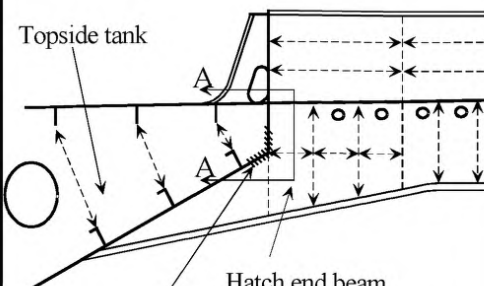
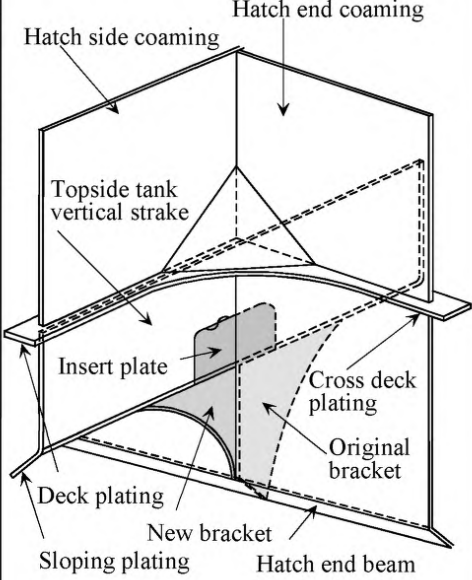
BULK CARRIERS		Guidelines for Surveys, Assessment and Repair of Hull Structure	
Part 1	Cargo hold region	Example No. 8	
Area 2	Topside tank structure		
Detail of damage		Fractures in sloping plating and vertical strake initiated from the connection of topside tank to hatch end beam	
Sketch of damage		Sketch of repair

<p>Topside tank</p> <p>Hatch end beam</p> <p>Fracture in sloping plating and vertical strake initiated from the connection of topside tank to hatch end beam</p> <p>Topside tank vertical strake</p> <p>Deck plating</p> <p>Fracture</p> <p>Hatch end beam</p> <p>Topside tank knuckle line</p> <p>Original bracket (See "Sketch of repair")</p> <p>View A-A</p>

Notes on possible cause of damage		Notes on repairs	
<ol style="list-style-type: none"> 1. Stress concentration at the connection of hatch end beam to topside tank. 		<ol style="list-style-type: none"> 1. Fractured part to be cropped and renewed with increased thickness. 2. Additional bracket should be considered for reinforcement.

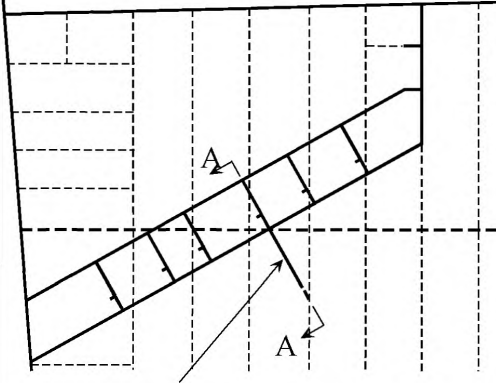
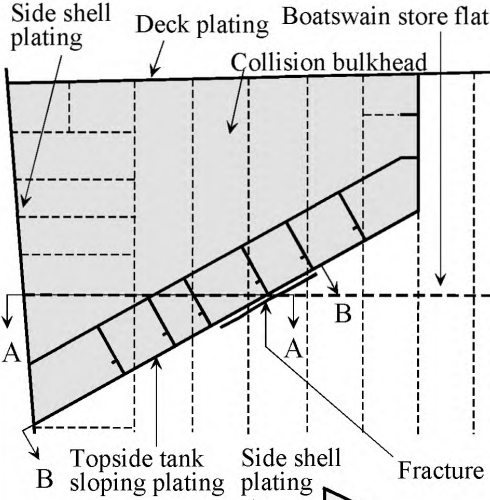
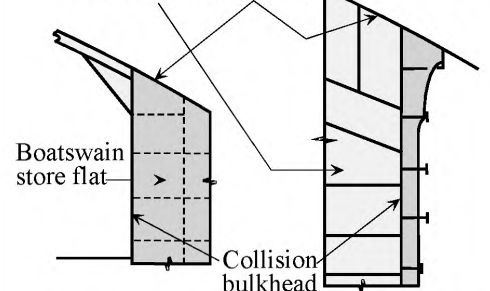
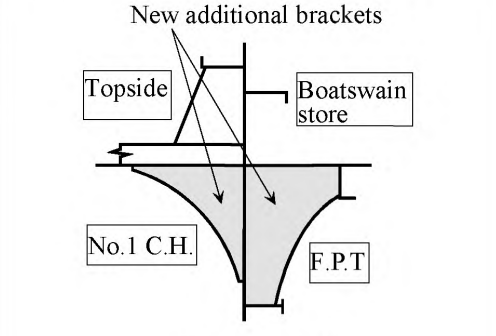
BULK CARRIERS		Guidelines for Surveys, Assessment and Repair of Hull Structure			
Part 1	Cargo hold region	Example No.			
Area 2	Topside tank structure	10			
Detail of damage		Fractures in way of collision bulkhead at intersection with topside tank structure in foremost cargo hold			
<p>Sketch of damage</p>

<p>Notes on possible cause of damage</p> <ol style="list-style-type: none"> 1. Damage caused by hard spot at intersection of the topside tank sloping plating and boatswain's store deck plating (fore peak tank top plating). 		<p>Notes on repairs</p> <ol style="list-style-type: none"> 1. Fractured plates to be cropped and renewed. 2. Stress concentration should be considered (Brackets were fitted on both sides for reinforcement).

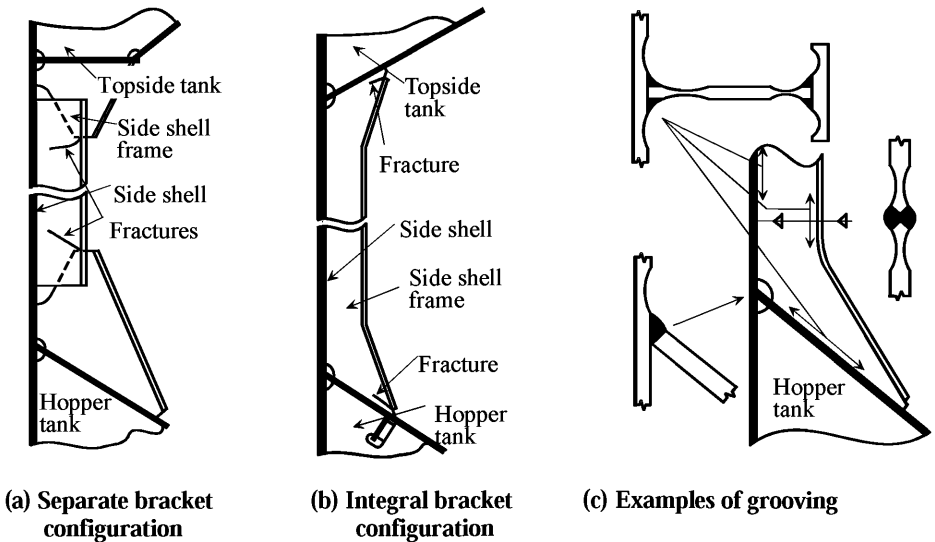
Figure 2 Damages to side shell frame - Potential problem areas

(Note) The type of bracket configuration used will, to a large extent, dictate the location and extent of fracture. Where separate brackets are employed, the fracture location is normally at the bracket toe position on the frames, whereas with integral brackets the location is at the toe position on the hopper and topside tank.

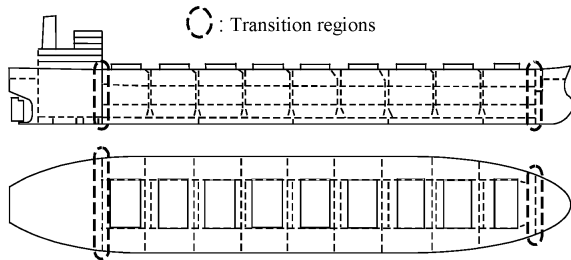
Figure 4 **Transition regions - Potential problem area**

- 1.5** The structure at the transition regions at the fore and aft ends of the ship are subject to stress concentrations due to structural discontinuities. The side shell plating at the transition regions is also subject to panting. The lack of continuity of the longitudinal structure, and the increased slenderness and flexibility of the side structure, makes the structure at the transition regions more prone to fracture damages.

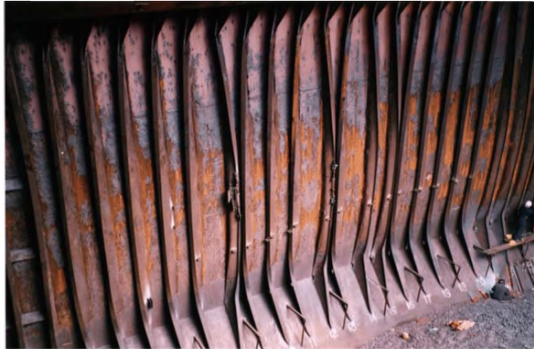
Photograph 1 Collapsed side shell frames (See Example 4)

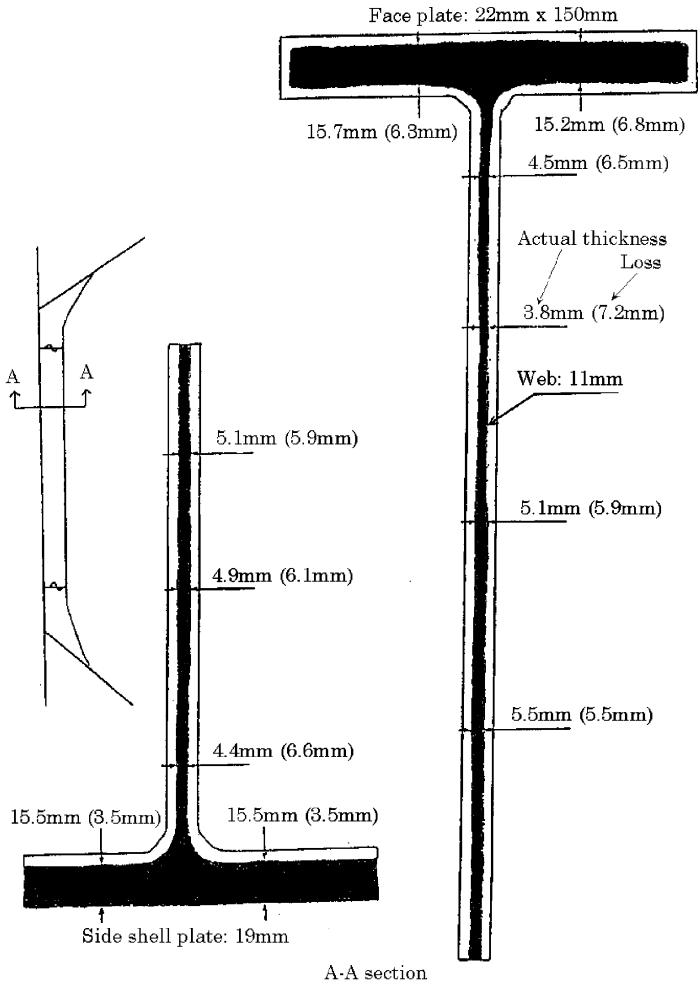
- 2.1.1 Attention is drawn to the fact that side shell frames may be significantly weakened by loss of thickness although diminution and deformations may not be apparent. Inspection should be made after the removal of any scale or rust deposit. Thickness measurements may be necessary, particularly if the corrosion is smooth and uniform, to determine the condition of the structure (See **Figure 5**).

Figure 5 Uniform corrosion of side shell frame

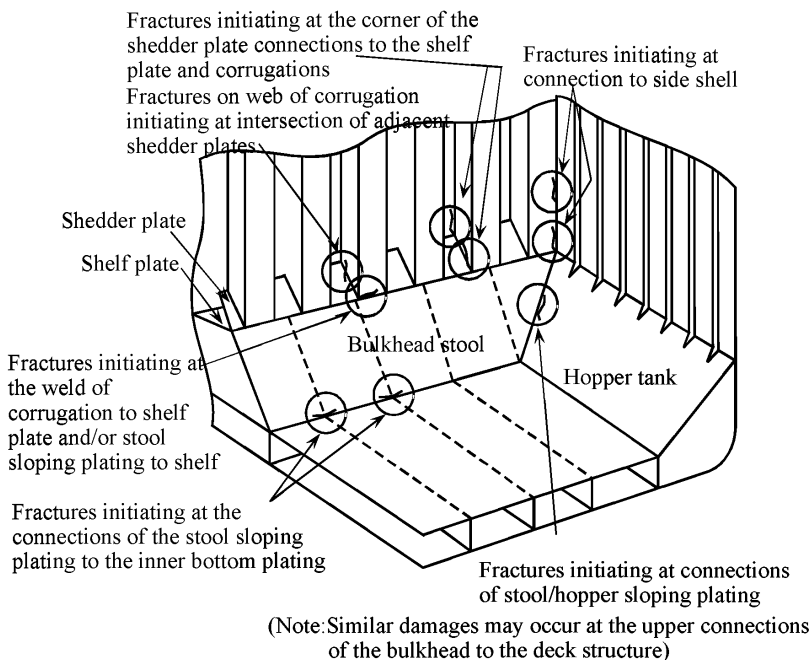
2.3.1 Fractures usually occur at the boundaries of corrugations and bulkhead stools particularly in way of shelf plates, shedder plates, deck, inner bottom, etc. (See **Figure 2**).

Figure 2 Typical fracturing at the connection of transverse bulkhead structure

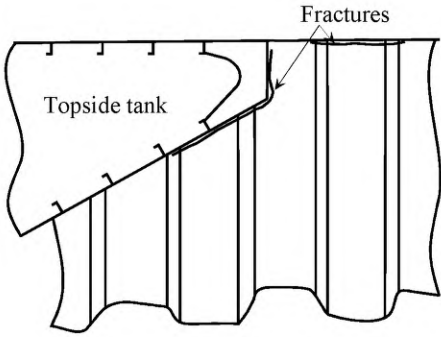
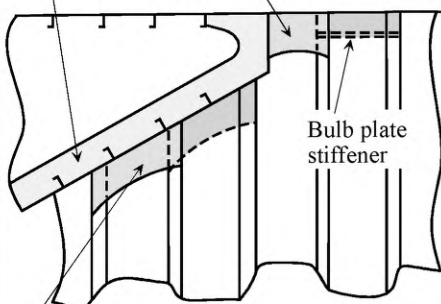
BULK CARRIERS		Guidelines for Surveys, Assessment and Repair of Hull Structure	
Part 1	Cargo hold region	Example No.	
Area 4	Transverse bulkhead and associated structure in cargo hold	2	
Detail of damage		Fractures at the upper boundaries to topside tanks	
Sketch of damage		Sketch of repair

<p>Continuous or intercostal reinforcement in line with flanges or gussets where not already fitted</p> <p>Adjacent to the topside tank either a gusset to a bulb plate stiffener may be</p>

Notes on possible cause of damage		Notes on repairs	
<ol style="list-style-type: none"> 1. Damage due to poor design and/or defective welds. 		<ol style="list-style-type: none"> 1. Fractures may be veed-out and rewelded. If necessary corrugated plating cropped and renewed. 2. It is recommended that reinforcement as shown above be incorporated, giving due consideration to the following criteria: <ol style="list-style-type: none"> 2.1 It is important to have the gusset plates well aligned with the transverse structure inside the tank. Gusset plates may be joggled to obtain this alignment. 2.2 If there is no transverse web already existing inside the topside tank and in line with the flanges of corrugation or gusset plates, reinforcement as shown above to be fitted.

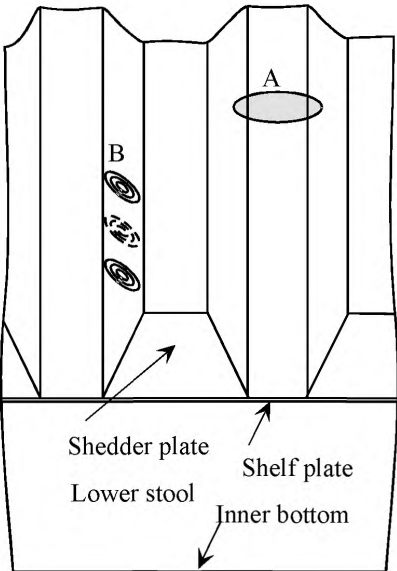
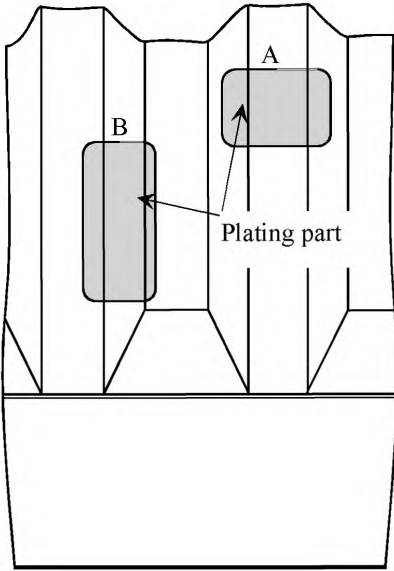
BULK CARRIERS		Guidelines for Surveys, Assessment and Repair of Hull Structure	
Part 1	Cargo hold region	Example No.	
Area 4	Transverse bulkhead and associated structure in cargo hold	3	
Detail of damage		Indentation and buckling of vertical corrugation	
Sketch of damage		Sketch of repair

Notes on possible cause of damage		Notes on repairs	
<ol style="list-style-type: none"> 1. Damages by mechanical abuse during cargo handling e.g. grab damage. 2. Damage resulting from thickness reduction by corrosion. 3. Buckling caused by bending or shear, see locations A and B respectively above, with a minimum reduction in thickness could be caused by underdesign or overloading. If this cause is suspected, the Classification Society concerned shall be contacted before proceeding with repairs. 		<ol style="list-style-type: none"> 1. Damage by mechanical abuse If the indentation/buckling is local and of a minor nature, the plating can be faired in place. If the deformation is more pronounced and/or in association with a generalized reduction in thickness the plating is to be cropped and renewed, as shown at locations A and B above. 2. Damage resulting from corrosion In this case thickness measurements are to be taken at mid-span and top and bottom of corrugations, and corrugations renewed or part renewed as necessary. Particular attention is to be given to the fit and alignment at corners of flanged corrugations when being partly renewed.

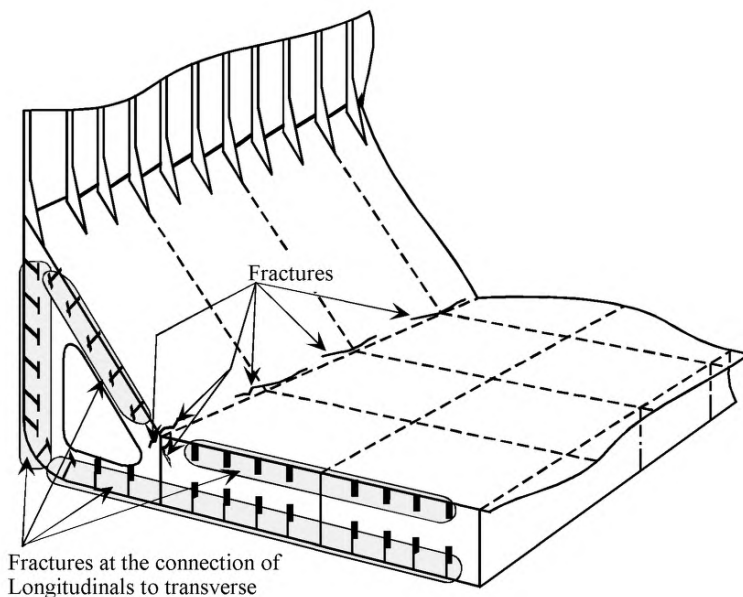
Figure 1 Typical fractures in the connection of hopper sloping plating to inner bottom (tank top) and longitudinal to transverse (or transverse bulkhead)

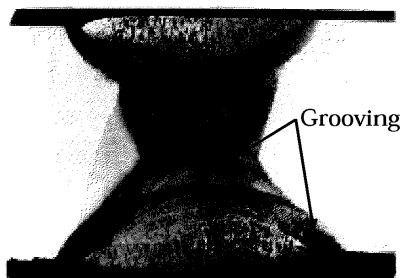
Photograph 2
Section of the grooving shown in Photograph 1

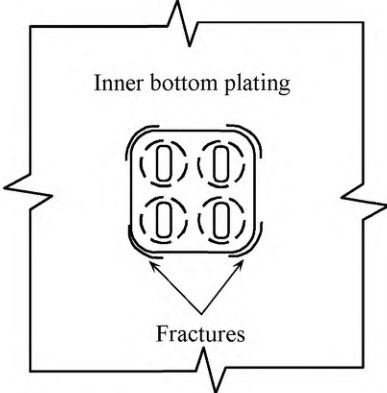
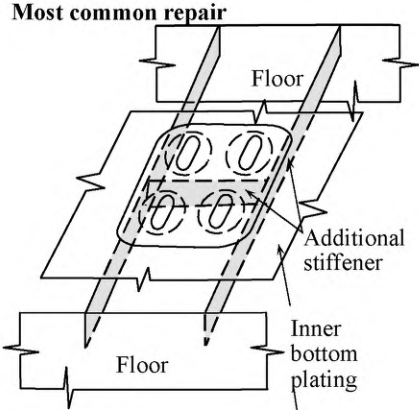
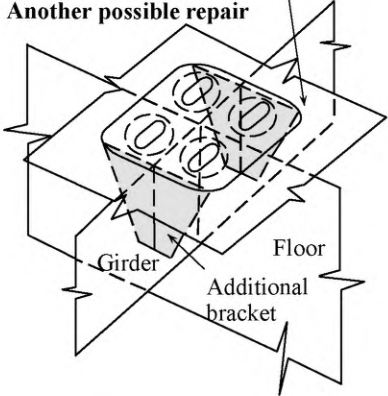
BULK CARRIERS		Guidelines for Surveys, Assessment and Repair of Hull Structure	
Part 1	Cargo hold region	Example No. 1	
Area 5	Double bottom structure including hopper	1	
Detail of damage		Fractures in inner bottom plating around container bottom pocket	
<p>Sketch of damage</p>

<p>Notes on possible cause of damage</p> <ol style="list-style-type: none"> 1. Pocket is not supported correctly by floor, longitudinal and/or stiffener. 		<p>Notes on repairs</p> <ol style="list-style-type: none"> 1. Fractured plating should be cropped and part renewed. 2. Adequate reinforcement should be considered.

<p>Sketch of repair</p> <p>Most common repair</p>

<p>Another possible repair</p>

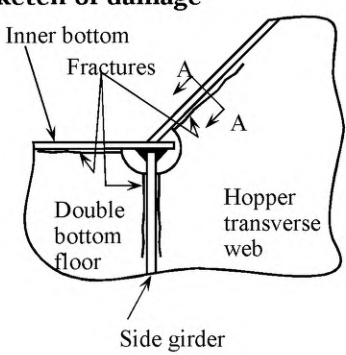
BULK CARRIERS		Guidelines for Surveys, Assessment and Repair of Hull Structure
Part 1	Cargo hold region	Example No.
Area 5	Double bottom tank structure including hopper	4
Detail of damage	Fractures at weld connections of floors in way of hopper/inner bottom interface (welded knuckle)	
<p>Sketch of damage</p>

<p>View A - A Transverse fractures in hopper web plating into possibly extending into the hopper sloping plating</p>

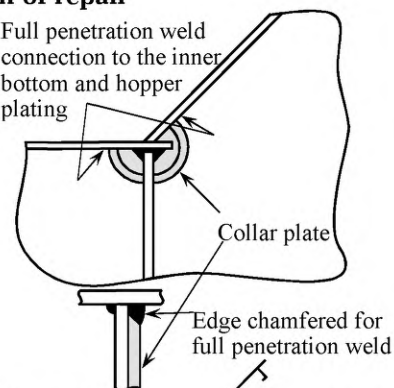
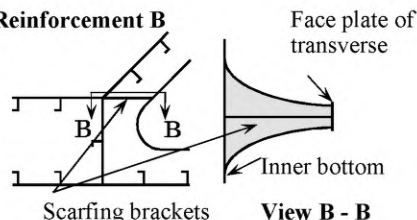
<p>View B - B</p>
<p>Notes on possible cause of damage</p> <ol style="list-style-type: none"> The damage is partly due to stress concentration at the edges of the weld created by the presence of the deflections in the inner bottom/hopper plating. 		<p>Notes on repairs</p> <ol style="list-style-type: none"> The fracture in the weld and/or plating is veed-out/cropped and renewed as appropriate. The cut-outs are eliminated by introducing suitable collar plates with emphasis on edge preparation and sequence of welding as shown above. Further reinforcements may be incorporated as shown above and depending on the judged cause of damage.

<p>Reinforcement A Alternatively, may stop at longitudinals where fitted</p>

<p>Reinforcement B</p>

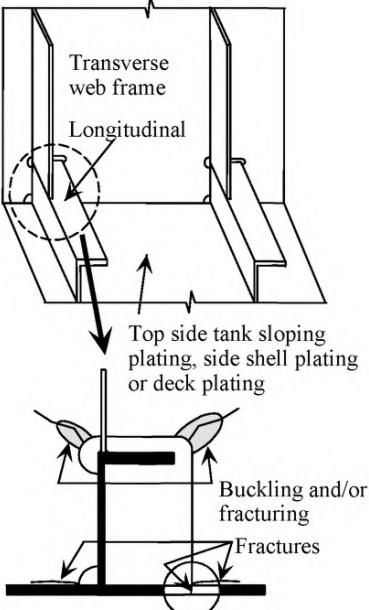
BULK CARRIERS		Guidelines for Surveys, Assessment and Repair of Hull Structure
Part 1	Cargo hold region	Example No.
Area 5	Double bottom tank structure including hopper	6
Detail of damage	Fractures and buckling in way of a cut-out for the passage of a longitudinal through a transverse primary member	
Sketch of damage	Sketch of repair

<p>Transverse web frame</p> <p>Longitudinal</p> <p>Top side tank sloping plating, side shell plating or deck plating</p> <p>Buckling and/or fracturing</p> <p>Fractures</p>	<p>Repair A</p>

<p>Full collar plate</p>	
Notes on possible cause of damage	Notes on repairs	
<p>1. Damage can be caused by general levels of corrosion and presence of stress concentration associated with the presence of a cut-out.</p>	<p>1. If fractures are significant then crop and part renew the floor plating/transverse web otherwise the fracture can be veed-out and welded provided the plating is not generally corroded.</p> <p>2. Repair B is to be incorporated if the lug proves to be ineffective.</p>

<p>Lug</p> <p>New plating of enhanced thickness</p> <p>Repair B</p>

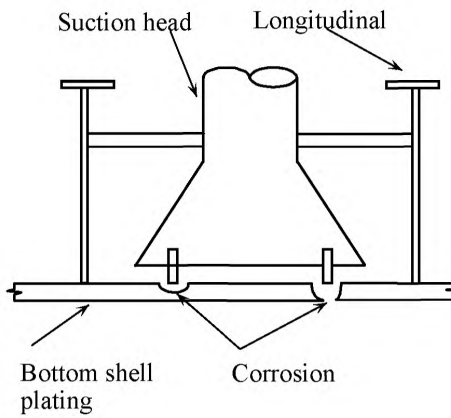
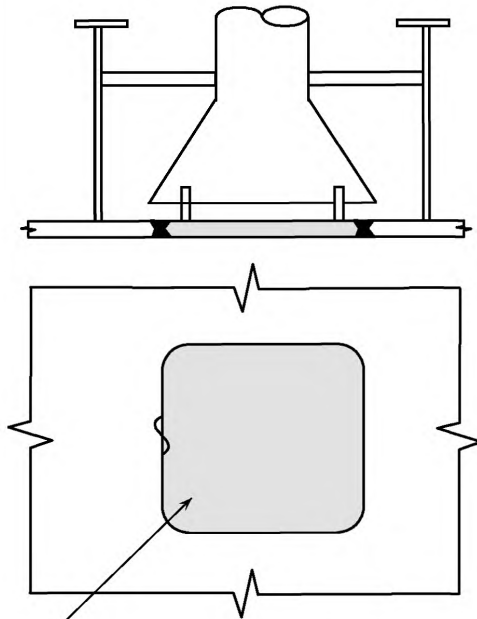
BULK CARRIERS		Guidelines for Surveys, Assessment and Repair of Hull Structure	
Part 1	Cargo hold region	Example No.	
Area 5	Double bottom tank structure including hopper	14	
Detail of damage		Corrosion in bottom plating below suction head	
Sketch of damage		Sketch of repair

<p>1. Insert to have round corners 2. Non-destructive examination to be applied after welding based on the Society's rules</p>	
Notes on possible cause of damage		Notes on repairs	
<ol style="list-style-type: none"> High flow rate associated with insufficient corrosion prevention system. Galvanic action between dissimilar metals. 		<ol style="list-style-type: none"> Affected plating should be cropped and part renewed. Thicker plate and suitable beveling should be considered. If the corrosion is limited to a small area, i. e. pitting corrosion, repair by welding is acceptable.

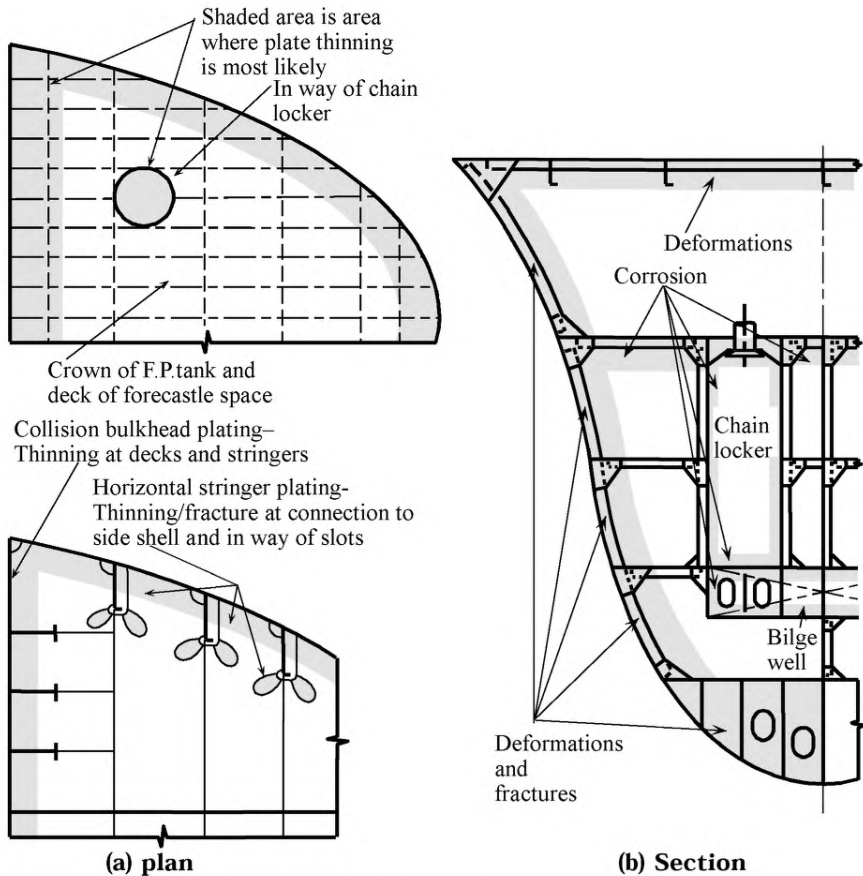
Fig 1 Fore end structure - Potential problem areas

- 2.1.1 Wastage (and possible subsequent fractures) is more likely to be initiated at the locations as indicated in **Figure 1** and particular attention should be given to these areas. A close-up inspection should be carried out with selection of representative thickness measurements to determine the extent of corrosion.
- 2.1.2 Structure in chain locker is liable to have heavy corrosion due to mechanical damage of the protective coating caused by the action of anchor chains. In some ships, especially smaller ships, the side shell plating may form boundaries of the chain locker and heavy corrosion may consequently result in holes in the side shell plating.

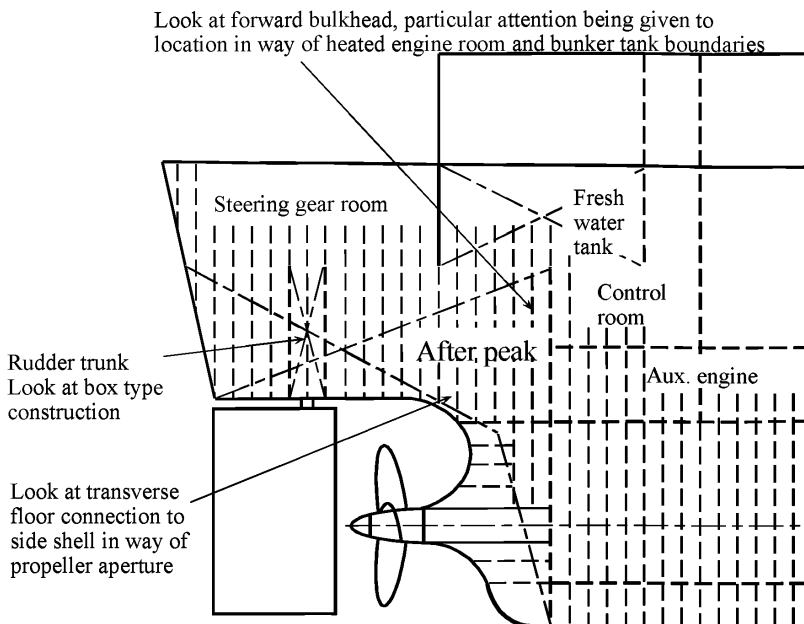
Figure 1 Aft end structure - Potential problem areas

- 2.3.1 Fractures in weld at floor connections and other locations in the aft peak tank and rudder trunk space can normally only be found by close-up inspection.
- 2.3.2 The structure supporting the rudder carrier may fracture and/or deform due to excessive load on the rudder. Bolts connecting the rudder carrier to the steering gear flat may also suffer damage under such load.

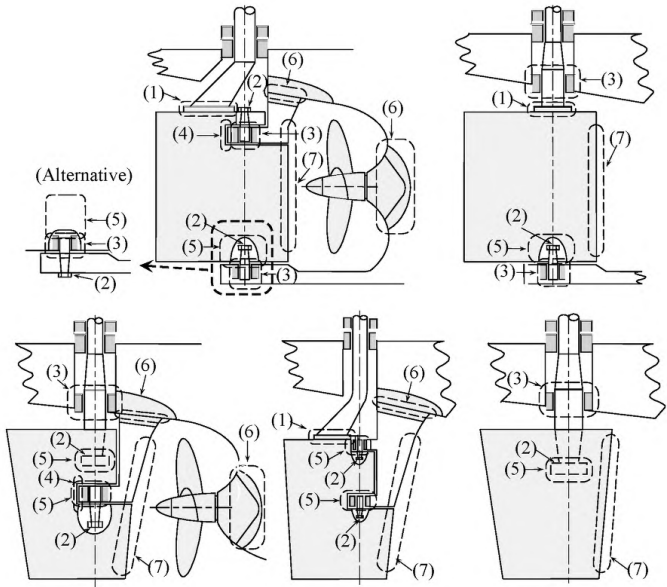
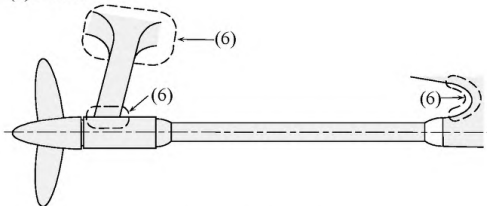
Figure 2 Potential problem areas

- 1.6 Pre-existing manufacturing internal defects in cast pieces may lead to fatigue cracking.
- 1.7 A summary of potential problem areas is shown in **Figure 2**.

Damage to look for:

- (1) Fractures and loose coupling bolts
- (2) Loose nut
- (3) Wear (excessive bearing clearance)
- (4) Fractures in way of pintle cutout
- (5) Fractures in way of removable access plate
- (6) Fractures
- (7) Erosion

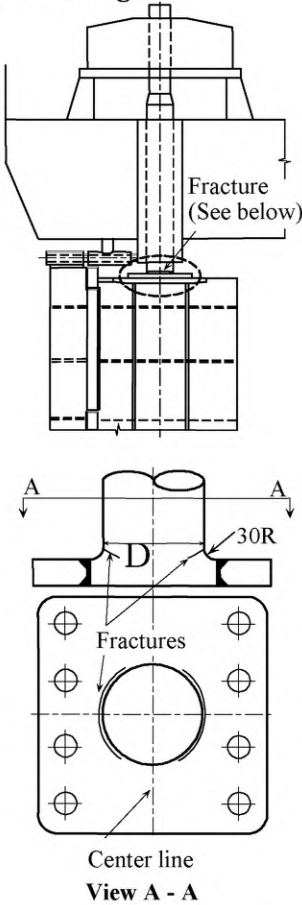
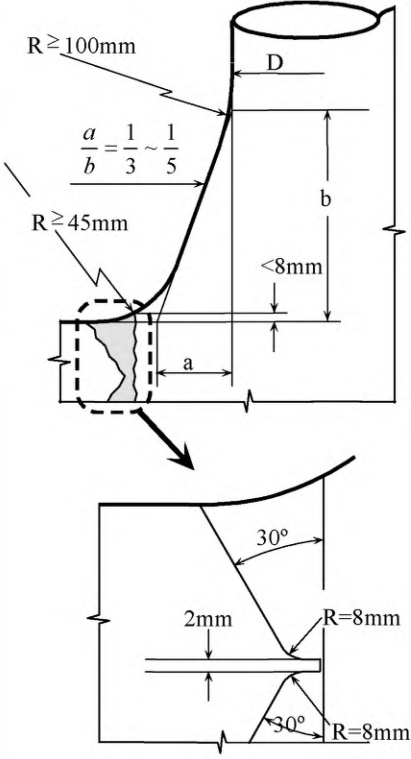
BULK CARRIERS	Guidelines for Surveys, Assessment and Repair of Hull Structure	
Part 2	Fore and aft end regions	Example No.
Area 3	Stern frame, rudder arrangement and propeller shaft support	2
Detail of damage Fractures in rudder stock		
<p>Sketch of damage</p>

<p>Notes on possible cause of damage</p> <ol style="list-style-type: none"> Inadequate design for stress concentration in rudder stock. 		<p>Notes on repairs</p> <ol style="list-style-type: none"> Modification of detail design of rudder stock to reduce the stress concentration.

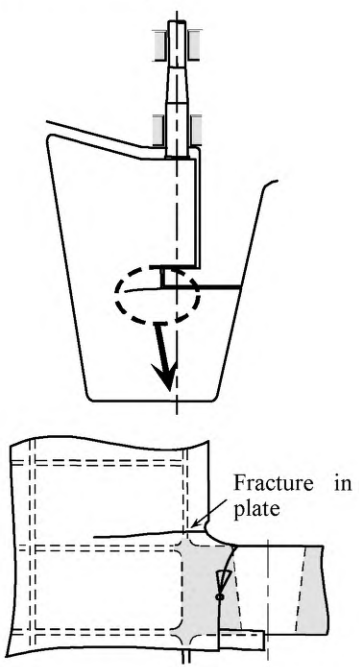
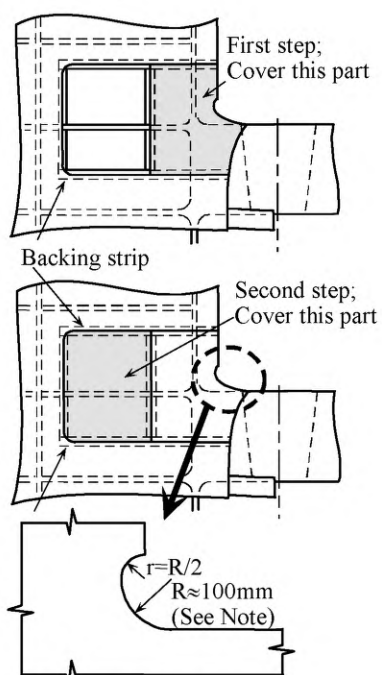
GENERAL CARGO SHIPS		Guidelines for Surveys, Assessment and Repair of Hull Structure
Part 2	Fore and aft end regions	Example No.
Area 3	Stern frame, rudder arrangement and propeller shaft support	5
Detail of damage	Fractures in rudder plating of semi-spade rudder extending beyond the vertical web	
Sketch of damage

<p>Note: R should be considered according to local detail</p>
Notes on possible cause of damage 1. Stress concentration due to inadequate local design and/or fabrication notches in way of the butt weld between cast piece and plating.		Notes on repairs 1. Fractured plating is to be cut-out. 2. Internal structures are to be checked. 3. Cut-out is to be closed by an insert plating according to the sketch (welding only from one side is demonstrated). 4. Modification of the radius. 5. In case of a new cast piece, connection with the plating is to be shifted outside the high stress area.

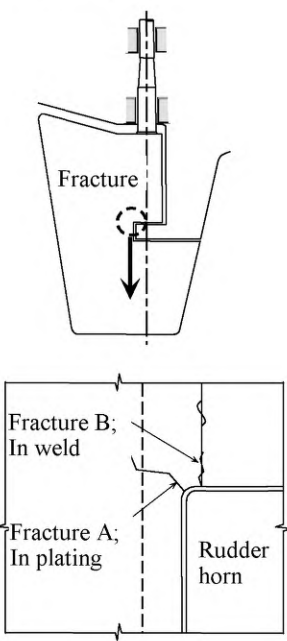
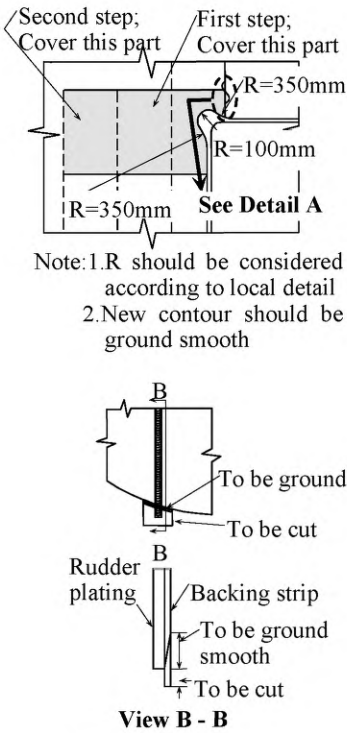
BULK CARRIERS	Guidelines for Surveys, Assessment and Repair of Hull Structure	
Part 2	Fore and aft end regions	Example No.
Area 3	Stern frame, rudder arrangement and propeller shaft support	6
Detail of damage	Fractures in rudder plating of semi-spade rudder in way of pintle cutout	
Sketch of damage	Sketch of repair

Notes on possible cause of damage	Notes on repairs	
<ol style="list-style-type: none"> Inadequate design for stress concentration in way of pintle bearing (Fracture A). Imperfection in welding seam (Fracture B). 	<ol style="list-style-type: none"> Fractured part to be cropped off. Repair by two insert plates of modified, stress releasing contour. For the vertical seam no backing strip is used 100mm off contour, welding from both sides, to be ground after welding. Variant (See Detail A): Repair as mentioned under 2 with the use of backing strip for the complete vertical seam. After welding backing strip partly removed by grinding.

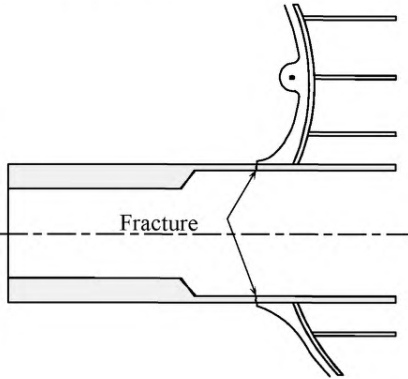
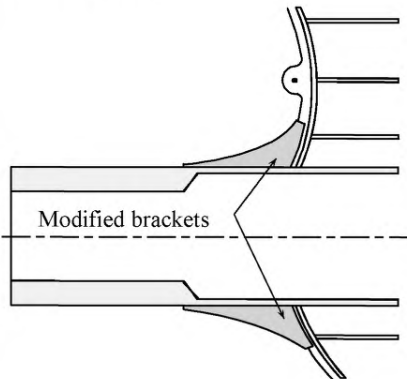
BULK CARRIERS		Guidelines for Surveys, Assessment and Repair of Hull Structure	
Part 2	Fore and aft end regions	Example No.	
Area 3	Stern frame, rudder arrangement and propeller shaft support	8	
Detail of damage		Fractures in stern tube at the connection to stern frame	
Sketch of damage		Sketch of repair

Notes on possible cause of damage		Notes on repairs	
<ol style="list-style-type: none"> 1. Fatigue fracture due to vibration. 		<ol style="list-style-type: none"> 1. Fractured tube is to be veed-out and welded from both sides. 2. Brackets are to be replaced by modified brackets with soft transition.

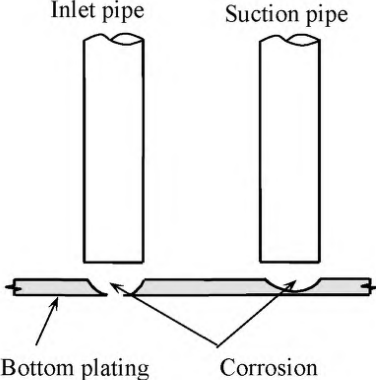
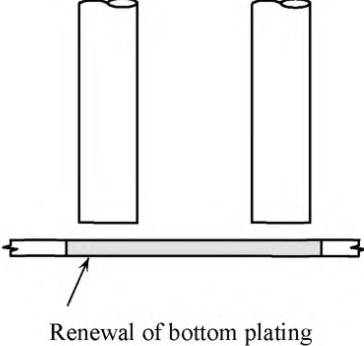
BULK CARRIERS		Guidelines for Surveys, Assessment and Repair of Hull Structure	
Part 3	Machinery and accommodation spaces		Example No.
Area 1	Engine room structure		3
Detail of damage	Corrosion in bottom plating under inlet/suction/pipe in way of bilge tank in engine room		
Sketch of damage		Sketch of repair

Notes on possible cause of damage		Notes on repairs	
<ol style="list-style-type: none"> 1. Heavy corrosion of bottom plating under the inlet/suction pipe. 		<ol style="list-style-type: none"> 1. Corroded bottom plating is to be cropped and part renewed. Thicker plate is preferable. 2. Replacement of pipe end by enlarged conical opening (similar to suction head in ballast tank) is preferable.
