No. 96 **Double Hull Oil Tankers - Guidelines for Surveys,
(April**
2007)

DOUBLE HULL OIL TANKERS

Guidelines for Surveys, Assessment and Repair
of Hull Structures

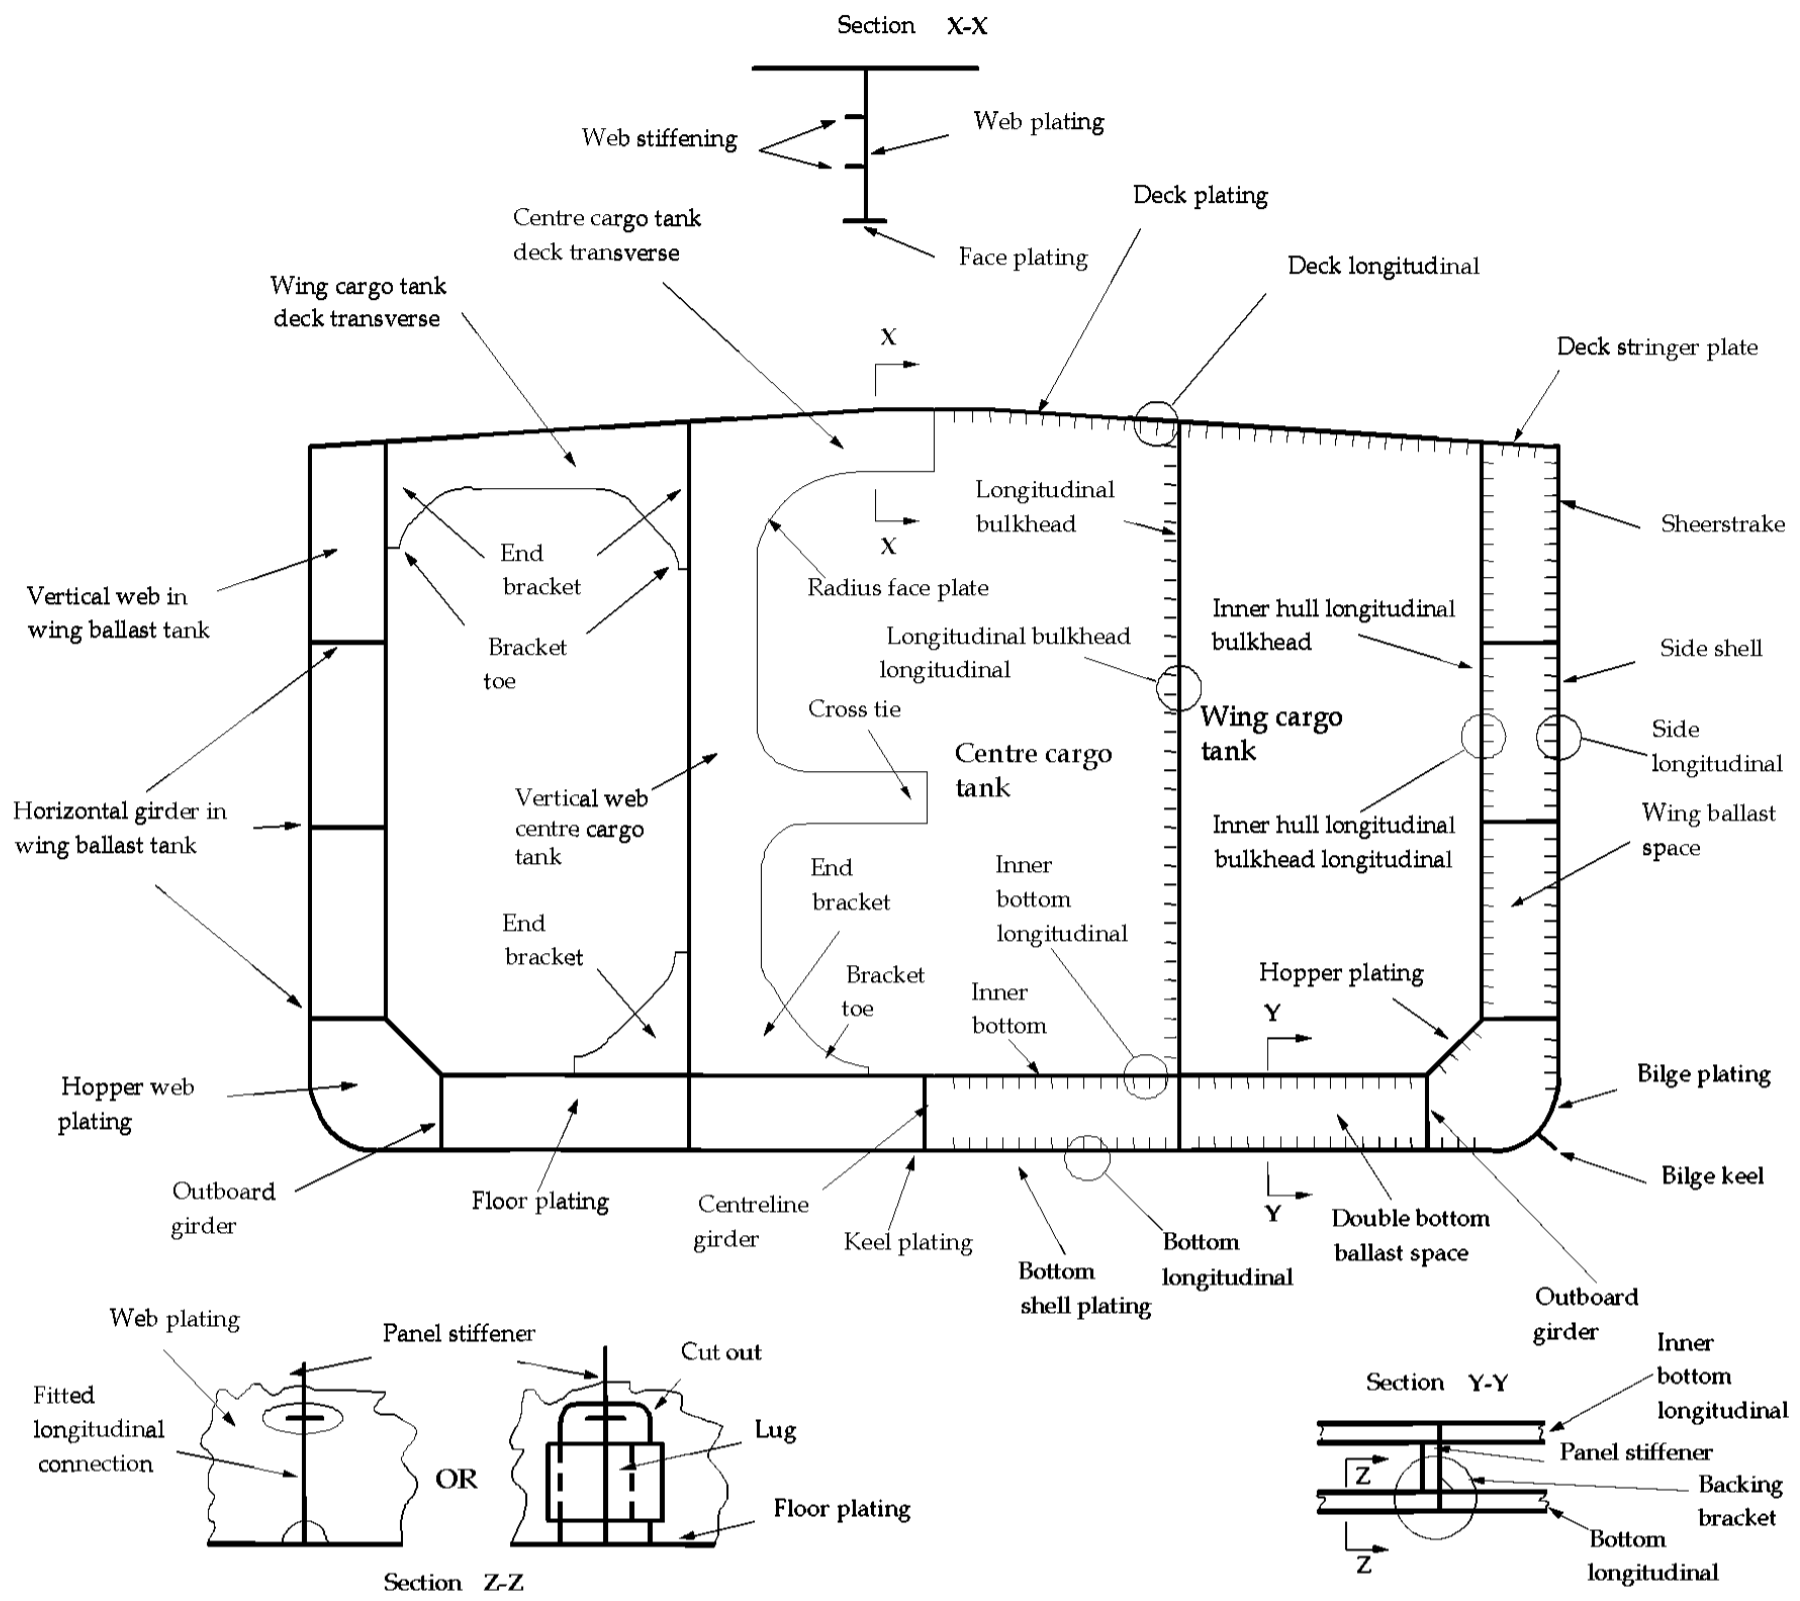
Figure 4 Typical midship section of a double hull oil tanker with two longitudinal bulkheads including nomenclature

Figures 4 to 6 show the typical nomenclature used for the midship section and transverse bulkhead.

3.2.1 For clarity of definition and reporting of survey data, it is recommended that standard nomenclature for structural elements be adopted. A typical midship section is illustrated in **Figures 4 to 6**. These figures show the generally accepted nomenclature.

1.1 The web frame is the support for the transfer of the loads from the longitudinals. This structure has critical points at the intersections of the longitudinals, openings for access through the web frames and critical intersections such as found at the hopper knuckles as well as any bracket terminations. See also Figures 3 and 4 in **Chapter 1 Introduction**.

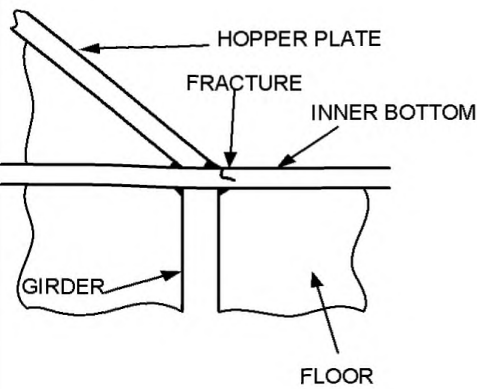
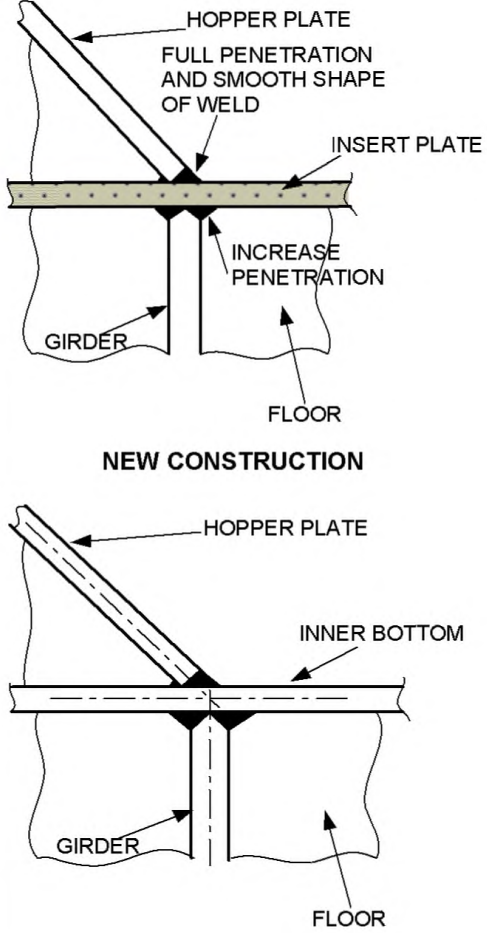
OIL Tankers		Guidelines for Surveys, Assessment and Repair of Hull Structure	
Group 1	Cargo area	Example No.	
	Hopper and double bottom ballast tank	1	
Detail of damage		Fracture on the inner bottom plating at the connection of hopper plate to inner bottom	
<p>Sketch of damage</p>

<p>Sketch of repair</p>

<p>Notes: Plate midlines intersect</p>	
<p>Factors which may have caused damage</p> <ol style="list-style-type: none"> 1. Stress concentration at juncture of hopper plate to inner bottom. 2. Insufficient welding connection. 3. Misalignment between hopper plate, inner bottom and girder. 		<p>Notes on repairs</p> <p>See Sketch.</p>

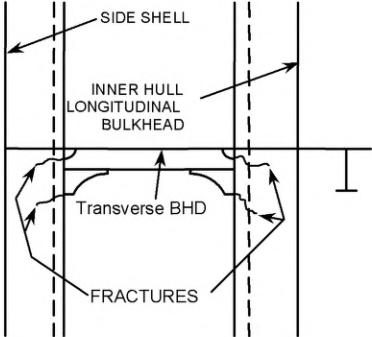
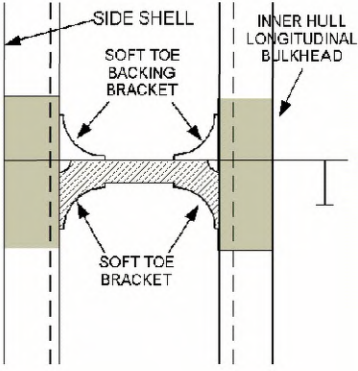
OIL Tankers		Guidelines for Surveys, Assessment and Repair of Hull Structure	
Group 2	Cargo area	Example No.	
	Wing ballast tank	1	
Detail of damage	Crack in way of connection of longitudinals to transverse bulkhead		
<p>Sketch of damage</p>

<p>The sketch shows a cross-section of the hull structure. On the left is the side shell. In the center is the inner hull longitudinal bulkhead. A horizontal transverse bulkhead (BHD) intersects it. Fractures are indicated by jagged lines at the connection points between the longitudinal bulkhead and the transverse BHD.</p>	<p>Sketch of repair</p>

<p>The repair sketch shows the same cross-section as the damage sketch. It adds two soft toe backing brackets (top) and two soft toe brackets (bottom) to reinforce the connection between the inner hull longitudinal bulkhead and the transverse bulkhead. The side shell and inner hull longitudinal bulkhead are also labeled.</p>

<p>Factors which may have caused damage</p> <ol style="list-style-type: none"> 1. Asymmetrical connection of bracket without backing bracket. 2. Relative deflection of adjoining transverse web against transverse bulkhead. 3. Additional biaxial bending stresses due to asymmetry of the angle bar longitudinal instead of symmetric T section. 4. Dynamic load in the vicinity of the water line. 5. Large upstand at bracket toe. 	<p>Notes on repairs See Sketch.</p>

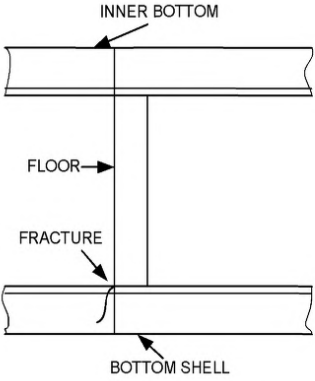
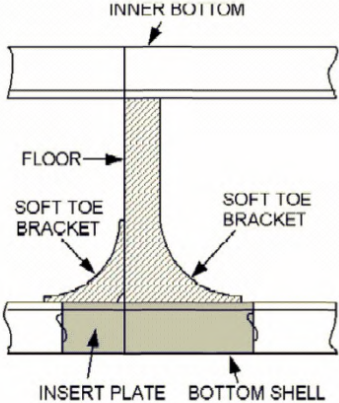
OIL Tankers		Guidelines for Surveys, Assessment and Repair of Hull Structure	
Group 3	Cargo area	Example No.	
	Bottom ballast tank	4	
Detail of damage		Connection of longitudinals to ordinary floors	
<p>Sketch of damage</p>

<p>Sketch of repair</p>

<p>Factors which may have caused damage</p> <ol style="list-style-type: none"> 1. Stress concentration at the connection of bottom longitudinal and stiffener on floor. 		<p>Notes on repairs</p> <p>See Sketch.</p> <ol style="list-style-type: none"> 1. Butt welds in bottom longitudinal should be kept clear of the soft toe bracket toes. 2. If possible soft toe bracket and vertical stiffener should be integral.

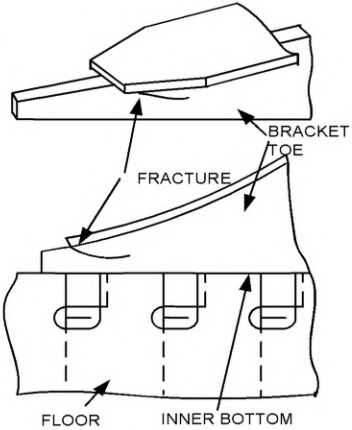
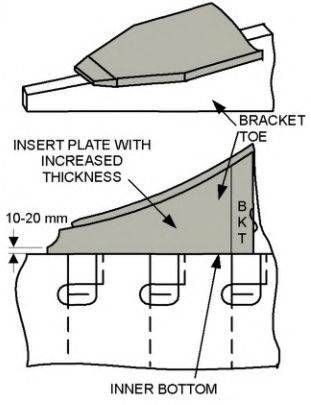
OIL Tankers		Guidelines for Surveys, Assessment and Repair of Hull Structure
Group 4	Cargo area	Example No.
	Web Frame in cargo tank	1
Detail of damage		Fracture at toe of web frame bracket connection to inner bottom.
<p>Sketch of damage</p>

<p>The sketch shows a perspective view of a bracket attached to a horizontal web frame. A crack, labeled 'FRACTURE', is shown at the 'BRACKET TOE' where the bracket meets the web frame. Below this, a plan view shows the 'FLOOR' and 'INNER BOTTOM' with three brackets attached. An arrow points from the fracture location in the perspective view to the corresponding bracket location in the plan view.</p>		<p>Sketch of repair</p> <p>Modify Face Taper</p> <ol style="list-style-type: none"> 1. Breadth taper 20 degrees. 2. Breadth at toe as small as practical. 3. Thickness taper 1 in 3 to 10mm.

<p>The repair sketch shows a perspective view of the bracket toe with a shaded 'INSERT PLATE WITH INCREASED THICKNESS' applied. A dimension line indicates a thickness of '10-20 mm' at the toe. Below, a plan view shows the 'INNER BOTTOM' with three brackets. An arrow points from the repair area in the perspective view to the corresponding bracket location in the plan view.</p>

<p>Factors which may have caused damage</p> <ol style="list-style-type: none"> 1. Inadequate tapering the toe end. 2. Insufficient tapering of flange. 3. Lateral flexing of the bracket. 		<p>Notes on repairs</p> <p>See Sketch.</p>

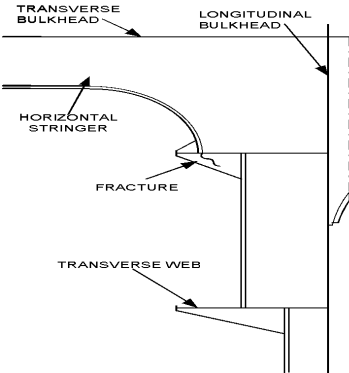
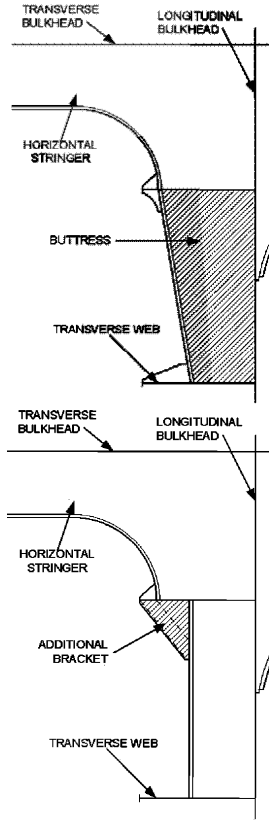
OIL Tankers		Guidelines for Surveys, Assessment and Repair of Hull Structure
Group 5	Cargo area	Example No.
	Transverse Bulkhead in cargo tank	1
Detail of damage	Fracture in way of connection of transverse bulkhead stringer to transverse web frames and longitudinal bulkhead stringer	
Sketch of damage	Sketch of repair

Factors which may have caused damage	Notes on repairs	
<ol style="list-style-type: none"> 1. Stress concentration due to discontinuous structure. 2. High shear stress in the horizontal stringer. 	<p>See Sketch.</p>

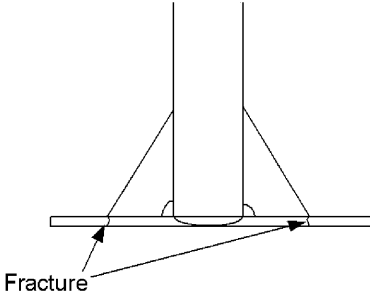
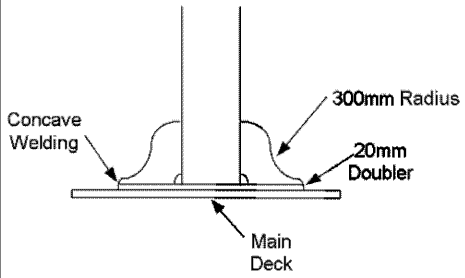
OIL Tankers		Guidelines for Surveys, Assessment and Repair of Hull Structure	
Group 6	Deck Structure		Example No.
			5
Detail of damage	Fractured deck plating in way of deck pipe support stanchions (midships)		
Sketch of damage		Sketch of repair

Factors which may have caused damage		Notes on repairs	
<p>1. Stanchions experience more severe relative displacements from hull girder bending.</p>		<p>See Sketch.</p>

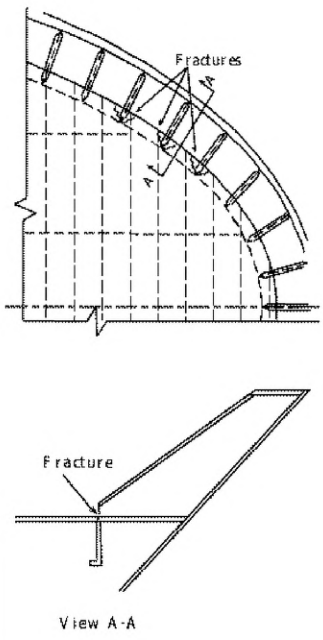
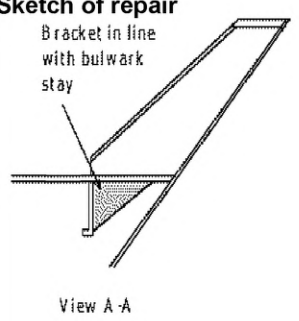
OIL Tankers		Guidelines for Surveys, Assessment and Repair of Hull Structure
Group 7	Fore region	Example No.
Area 1	Forecastle	1
Detail of damage		Fracture in forecastle deck plating at bulwark
<p>Sketch of damage</p>

<p>Sketch of repair</p>

<p>Factors which may have caused damage</p> <ol style="list-style-type: none"> 1. Bow Flare effect in heavy weather. 2. Stress concentration due to poor design. 		<p>Notes on repairs</p> <ol style="list-style-type: none"> 1. Fractured deck plating should be cropped and renewed. 2. Bracket in line with the bulwark stay to be fitted to reduce stress concentration.

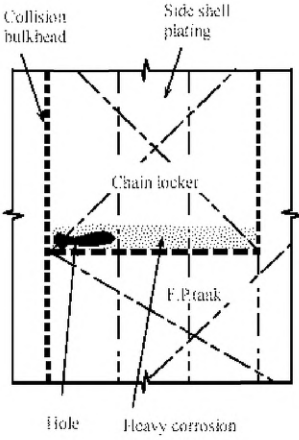
OIL Tankers		Guidelines for Surveys, Assessment and Repair of Hull Structure
Group 7	Fore region	Example No.
Area 1	Chain locker	2
Detail of damage		Fractures in side shell plating in way of chain locker
Sketch of damage

<p>The sketch shows a cross-section of the hull structure. On the left is a vertical dashed line labeled 'Collision bulkhead'. To its right is the 'Side shell plating'. A horizontal dashed line represents the 'Chain locker'. Below the chain locker is the 'F.P. tank'. A dark, irregular shape on the side shell plating is labeled 'Hole'. Below the hole, the area is shaded and labeled 'Heavy corrosion'. Dashed lines indicate structural members and boundaries.</p>		Sketch of repair

Factors which may have caused damage 1. Heavy corrosion in region where mud is accumulated.		Notes on repairs 1. Corroded plating should be cropped and renewed. 2. Protective coating should be applied.

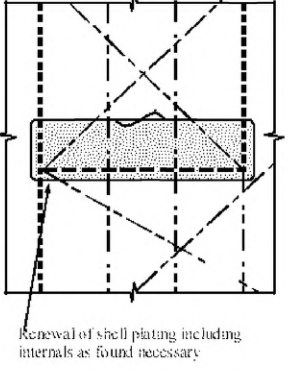
<p>The sketch shows the same hull structure as the damage sketch, but with a shaded rectangular area representing the 'Renewal of shell plating including internals as found necessary'. This area covers the hole and extends slightly beyond it. A dashed line indicates the boundary of the renewed area.</p>

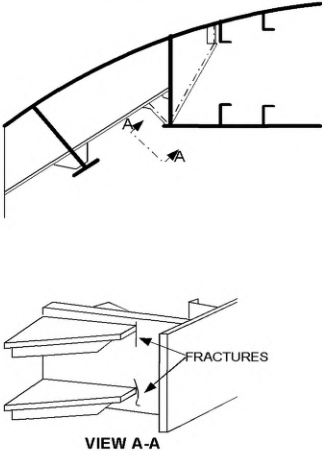
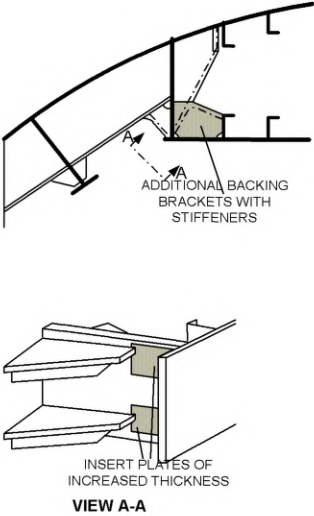
OIL Tankers		Guidelines for Surveys, Assessment and Repair of Hull Structure
Group 7	Fore region	Example No.
Area 1	Forepeak ballast tank	4
Detail of damage	Fractured vertical web at the longitudinal stiffener ending in way of the parabolic bow structure.	
Sketch of damage	Sketch of repair

<p>VIEW A-A</p>

<p>VIEW A-A</p>	
Factors which may have caused damage <ol style="list-style-type: none"> 1. Stress concentrations at bracket ending due to inadequate support at bracket toes in way of connection to web frame members. 2. Localised thinning in way of coating failure at bracket endings due to flexing of the structure. 3. Dynamic seaway loadings at bow causing flexing at bracket endings. 	Notes on repairs See Sketch.

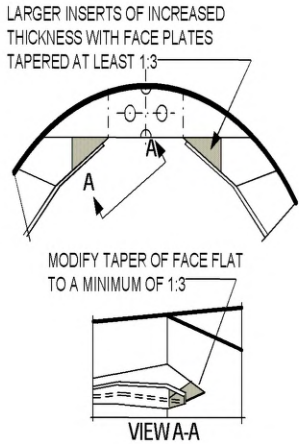
OIL Tankers		Guidelines for Surveys, Assessment and Repair of Hull Structure	
Group 7	Fore region	Example No.	
Area 1	Forepeak ballast tank	6	
Detail of damage		Fracture at end of longitudinal at bow structure.	
Sketch of damage		Sketch of repair

<p>A cross-sectional sketch of the forepeak ballast tank structure. It shows a curved shell plating at the top. Below it, two side longitudinal members are shown. Arrows point to the junctions between the shell plating and the side longitudinals, labeled 'FRACTURES'. The side longitudinals are labeled 'SIDE LONGITUDINALS'.</p>

<p>A cross-sectional sketch of the repair. It shows the same structure as the damage sketch, but with larger inserts of increased thickness at the fracture locations. The inserts are tapered at a minimum of 1:3. The text reads: 'LARGER INSERTS OF INCREASED THICKNESS WITH FACE PLATES TAPERED AT LEAST 1:3'. A detail view labeled 'VIEW A-A' shows a close-up of the repair, with the text: 'MODIFY TAPER OF FACE FLAT TO A MINIMUM OF 1:3'.</p>

Factors which may have caused damage		Notes on repairs	
<ol style="list-style-type: none"> 1. Inadequate brackets forming the longitudinal endings at bow structure. 2. Localised thinning in way of coating failure at longitudinal endings due to flexing of the structure. 3. Dynamic seaway loadings at bow causing flexing at longitudinal endings. 		<p>See Sketch.</p>

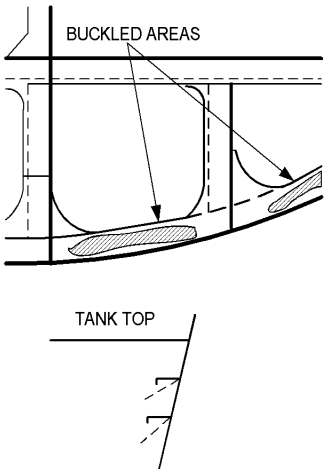
OIL Tankers		Guidelines for Surveys, Assessment and Repair of Hull Structure	
Group 7	Fore region		Example No.
Area 1	Fore peak ballast tank		8
Detail of damage		Buckled and tripped breasthooks	
Sketch of damage		Sketch of repair

<p>The sketch shows a cross-section of the fore peak ballast tank. The top structure is labeled 'BUCKLED AREAS' with arrows pointing to distorted regions. Below the tank, a detail of the 'TANK TOP' is shown with a vertical line and a horizontal line, indicating a structural joint.</p>

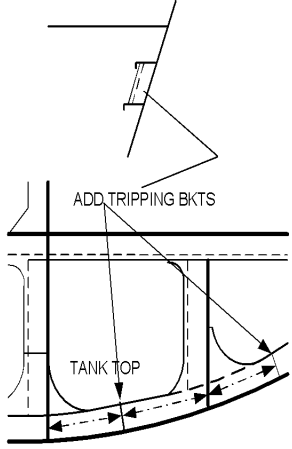
<p>The repair sketch shows the same cross-section with 'ADD. TRIPPING BKTS' (brackets) added to the top structure. A detail of the 'TANK TOP' is also shown, similar to the damage sketch but with a different joint configuration.</p>	
Factors which may have caused damage		Notes on repairs	
<ol style="list-style-type: none"> 1. Bow impact load. 2. Low buckling resistance. 		<p>See Sketch.</p>

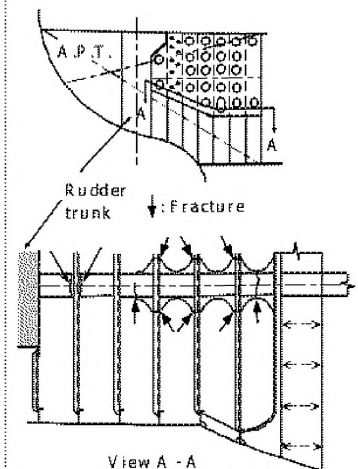
OIL Tankers		Guidelines for Surveys, Assessment and Repair of Hull Structure	
Group 7	Aft region	Example No.	
Area 2	Aft peak ballast tank	10	
Detail of damage	Fractures at the connection of floors and girders/side brackets		
Sketch of damage		Sketch of repair

<p>The sketch shows a cross-section of the hull structure. At the top, a curved section is labeled 'A.P.T.'. Below it, a horizontal structure is labeled 'Rudder trunk'. A vertical line indicates a 'Fracture' at the connection of floors and girders/side brackets. The view is labeled 'View A - A'.</p>

3.3.2 In order to prevent recurrence of damages suspected to be caused by main engine or propeller excited vibration, the cause of the vibration should be ascertained and additional reinforcements provided as found necessary (See Examples 9 and 10).

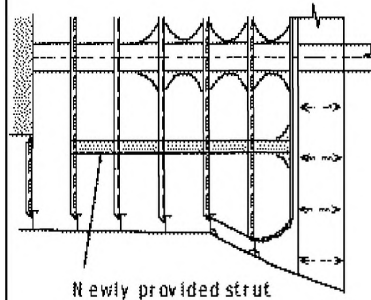
<p>The sketch shows a cross-section of the hull structure after repair. A 'Newly provided strut' is shown in the center, supported by brackets on either side. The structure is shown in a perspective view.</p>	
Factors which may have caused damage		Notes on repairs	
<ol style="list-style-type: none"> 1. Vibration. 		<ol style="list-style-type: none"> 1. The fractured plating should be cropped and renewed. 2. Natural frequency of the panel should be changed, e.g. reinforcement by additional strut.

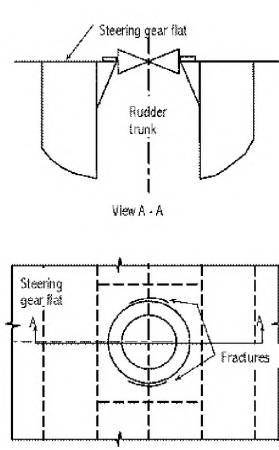
OIL Tankers		Guidelines for Surveys, Assessment and Repair of Hull Structure	
Group 7	Aft region	Example No.	
Area 2	Machinery space outside Engine room	11	
Detail of damage		Fractures in flat where rudder carrier is installed in steering gear room	
<p>Sketch of damage</p>

<p>View A - A</p>		<p>Sketch of repair</p>

3.3.4 Fractured structure which supports rudder carrier is to be cropped, and renewed, and may have to be reinforced (See Examples 11 and 12).

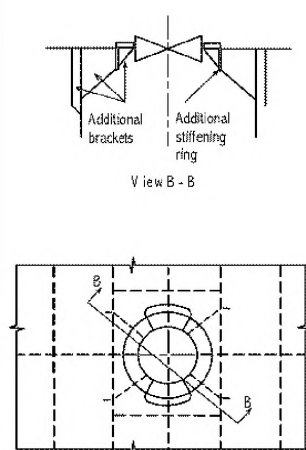
<p>View B - B</p>	
<p>Factors which may have caused damage</p> <ol style="list-style-type: none"> 1. Inadequate design. 		<p>Notes on repairs</p> <ol style="list-style-type: none"> 1. Fractured plating should be cropped and renewed. 2. Additional brackets and stiffening ring should be fitted for reinforcement.

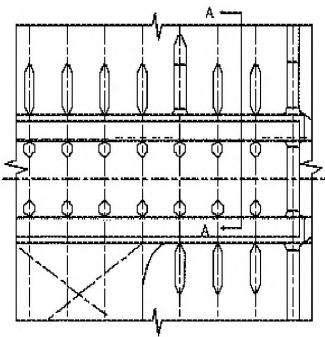
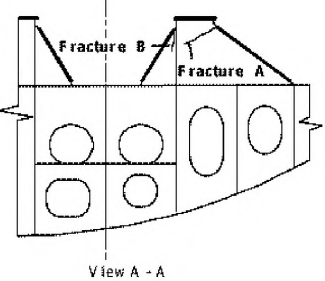
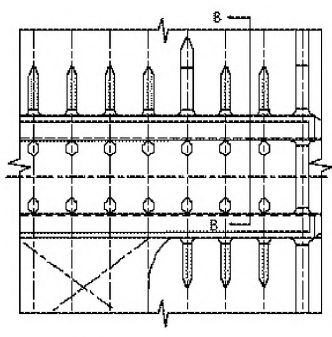
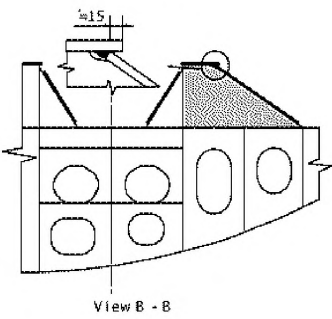
OIL Tankers		Guidelines for Surveys, Assessment and Repair of Hull Structure	
Group 8	Machinery and accommodation spaces	Example No.	
Area 1	Engine room	1	
Detail of damage		Fractures in brackets at main engine foundation	
Sketch of damage		Sketch of repair

<p style="text-align: center;">View A - A</p>

<p style="text-align: center;">View B - B</p>	
Factors which may have caused damage		Notes on repairs	
<ol style="list-style-type: none"> 1. Vibration of main engine. 2. Insufficient strength of brackets at main engine foundation. 3. Insufficient pre-load of the bolts. 		<ol style="list-style-type: none"> 1. Fractures may be veed-out and rewelded. 2. New modified brackets at main engine foundation. 3. Or insert pieces and additional flanges to increase section modulus of the brackets.

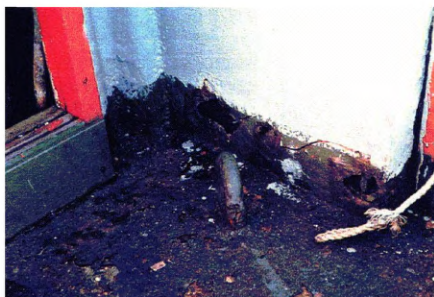
Photograph 1 Corroded accommodation house side structure

Severe corrosion may be found in exposed deck plating and deck house side structure adjacent to the deck plating where water is liable to accumulate (See **Photograph 1**). Corrosion may also be found in accommodation bulkheads around cut-out for fittings, such as doors, side scuttles, ventilators, etc., where proper maintenance of the area is relatively difficult. Deterioration of the bulkheads including fittings may impair the integrity of weathertightness.
